CHAPTER 3

MONITORING DATA

3.1 Data Collection

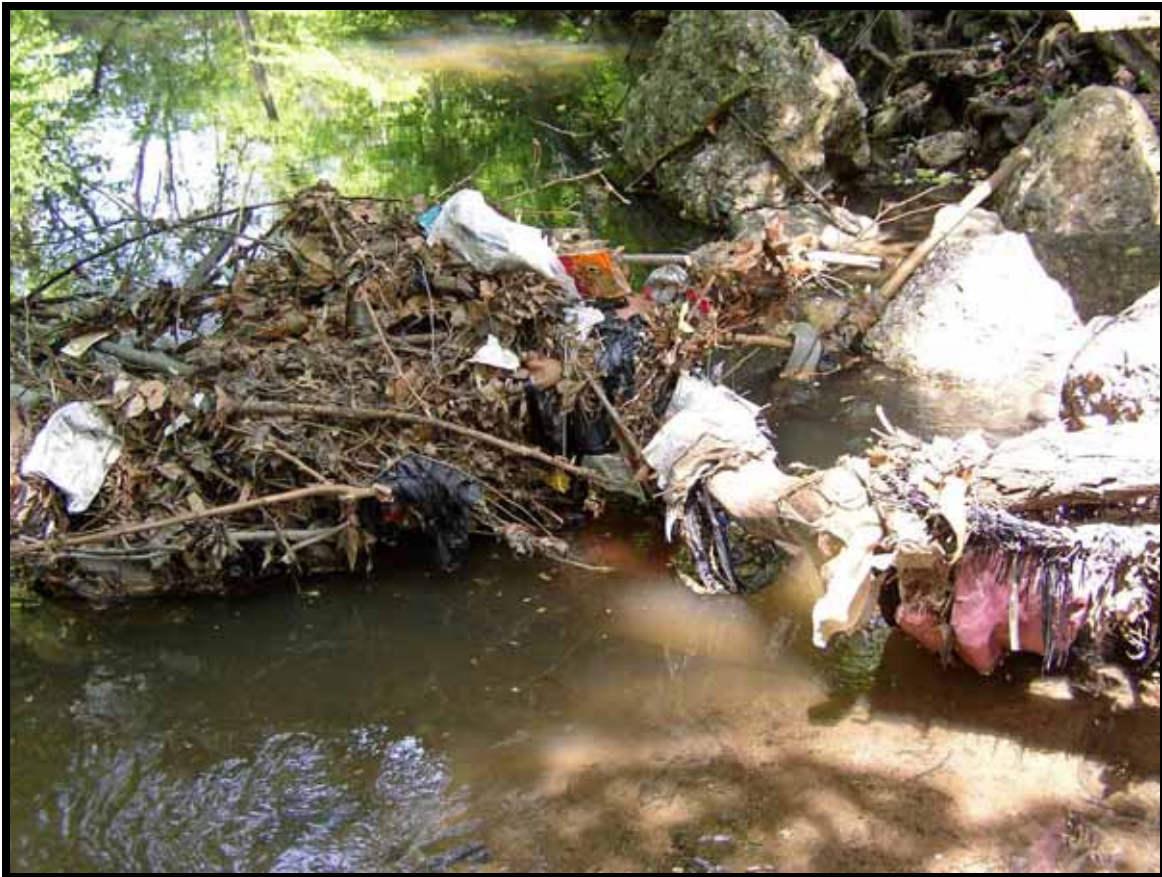
Figure 3.1.1
Trash collected by a log jam

Only visible trash was counted. In cases where there were several hundred items present of the same type such as plastic bags and food wrappers, estimates would be used instead of a detailed count. As can be seen in Figure 3.1.1, certain items are visible and easily counted individually. The plastic bags wrapped around the limb in the foreground would be estimated, the few that are visible in the log jam would be counted individually and the ones buried in the leaves out of sight would not be counted. Such log jams would be counted from the front and the rear to insure all visible trash was recorded.

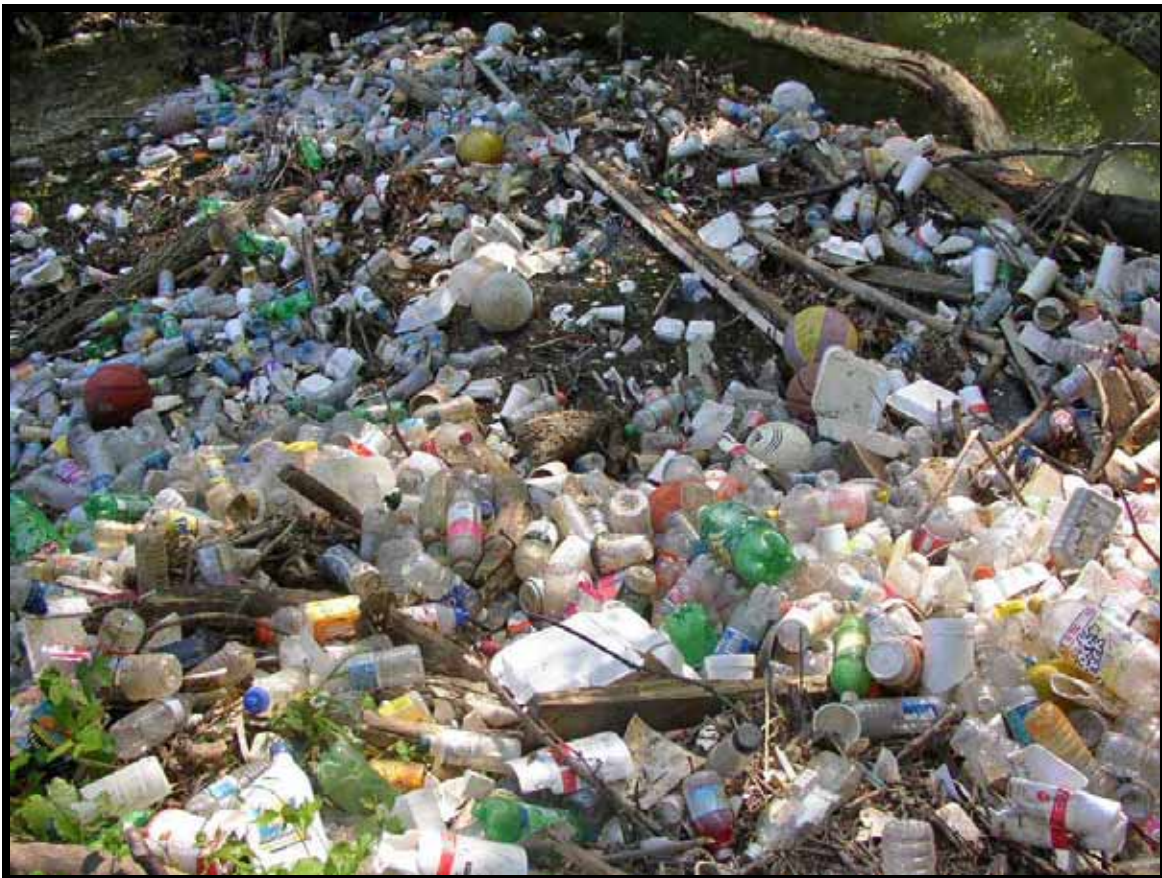
Figure 3.1.2
Most extreme example of undercounting due to methodology used

The photo below (Figure 3.1.2) is probably the most extreme situation of undercounting that occurred. The bottles and cups are nearly two feet deep on the photo bottom and left side, which means that nearly a third of the items are not visible, and by the methodology used, are not counted.

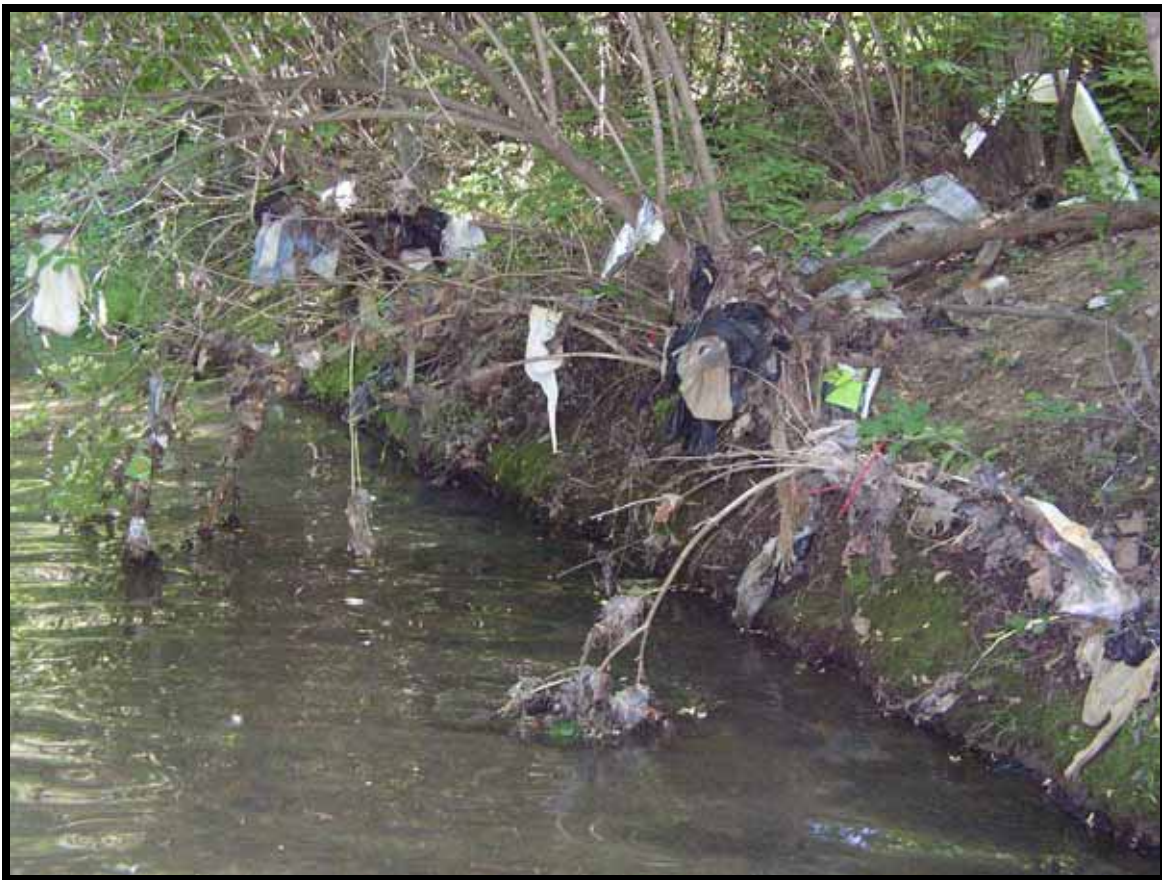
Figure 3.1.3
Bankfull Depth

The survey counted to bank full depth. In Figure 3.1.3 below, demonstrates that such a measure is open to judgment. This photo was taken on the last survey and one will notice that there is a piece of vinyl siding in the upper right hand corner wrapped around a tree. That piece of siding has probably moved 3 miles downstream in nine months.

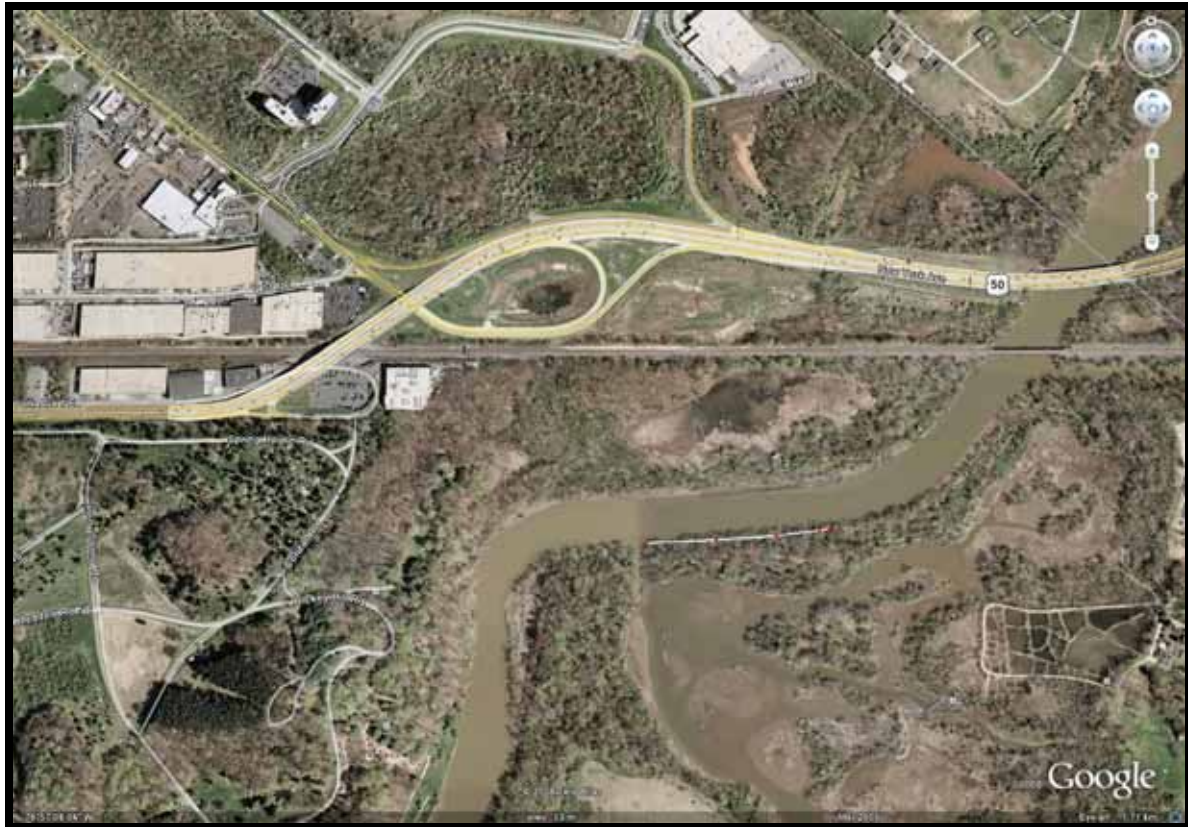
Figure 3.1.5
Anacostia Mainstream Stations: New York Avenue Bridge

CHANNEL VEGETATION, ROOTS, OBSTRUCTIONS: 1 very sparse vegetation in the channel

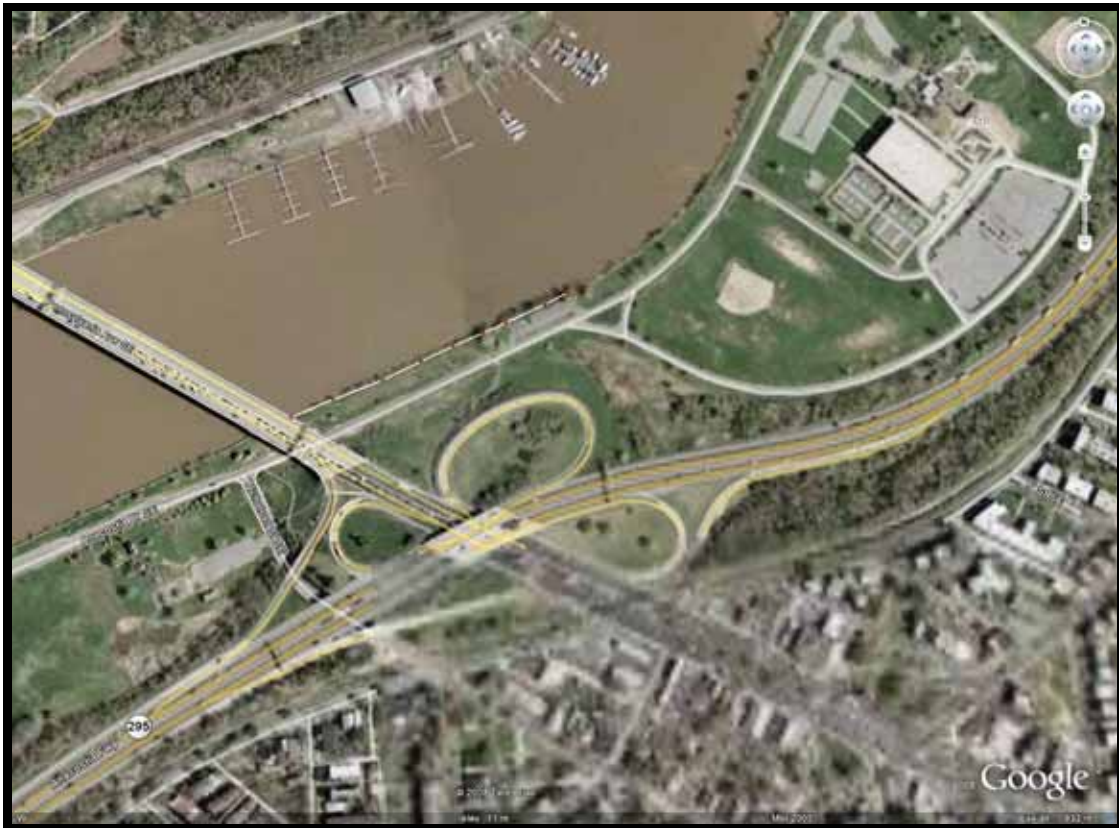
Figure 3.1.6
Anacostia: Pennsylvania Avenue Storm Sewer

START DESCRIPTION: UPSTREAM EDGE OF PARKING LOT
END DESCRIPTION: UPSTREAM EDGE OF PENN AVE BRIDGE
LENGTH: 875'
WIDTH: SEAWALL TO MIDCHANNEL
BANKFULL DEPTH: 2 FEET
CHANNEL VEGETATION, ROOTS, OBSTRUCTIONS: 1 SPARSE

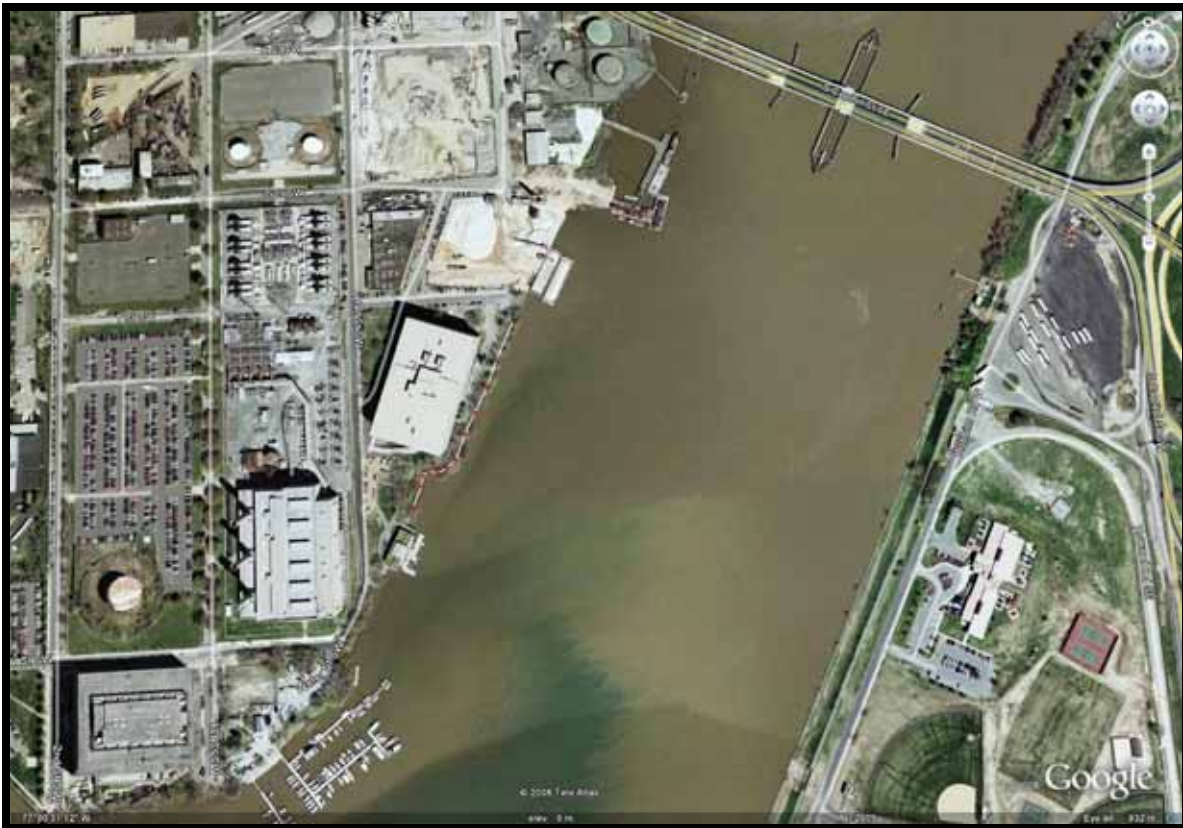
Figure 3.1.7
Anacostia: Buzzard Point

CHANNEL VEGETATION, ROOTS, OBSTRUCTIONS: 2 – RIPRAP ALONG BANK

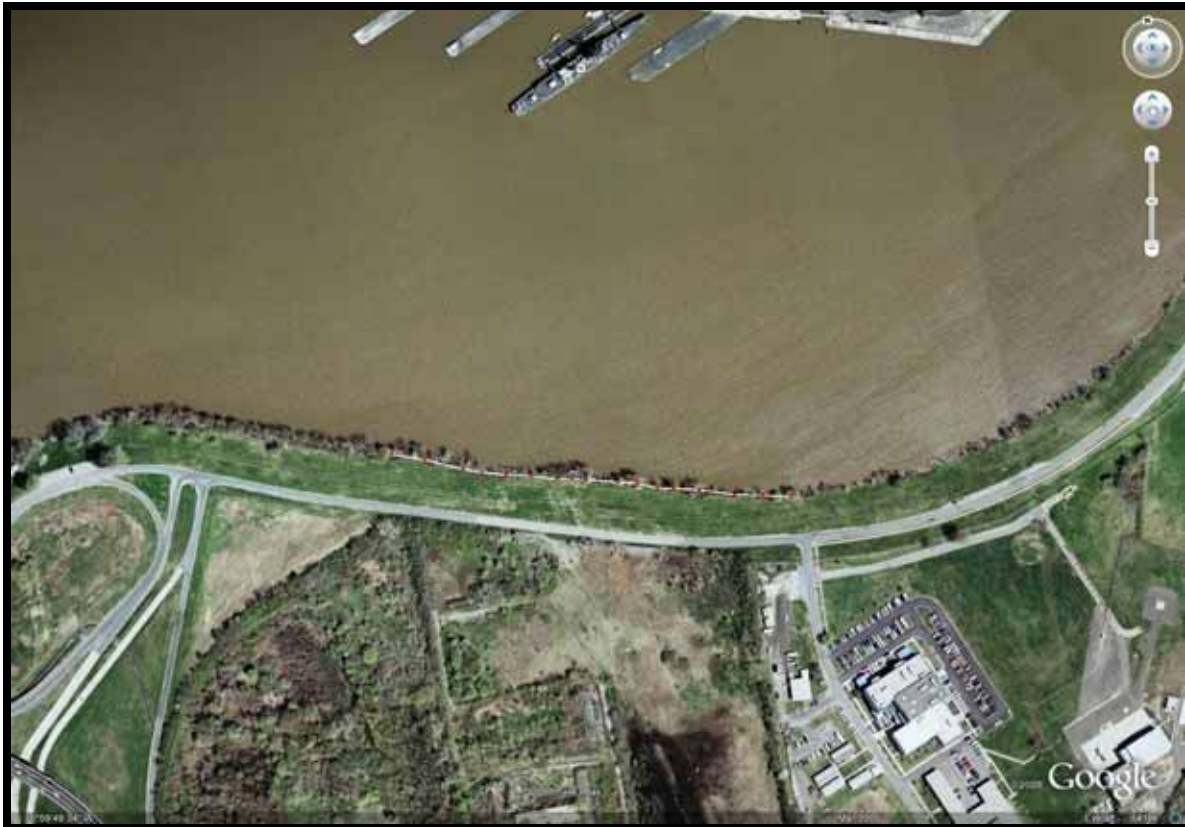
Figure 3.1.8
Anacostia: Poplar Point

The Seawall was broken in places. Upstream of stick foot sewer for 600 feet the trash was counted behind the seawall to high tide line. Below the Stickfoot sewer, trash was counted only in front of seawall

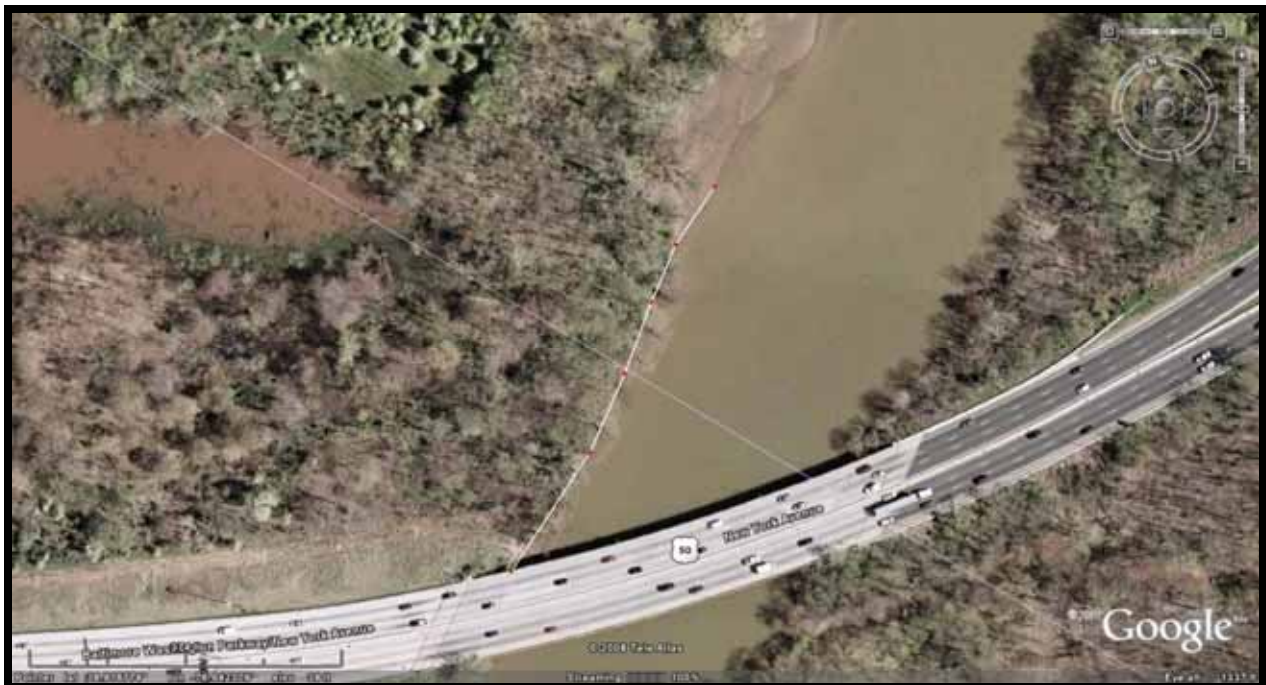
Figure 3.1.9
Anacostia: Above New York Avenue

This station straddles the DC/MD boundary and was added after the midterm review of the data.

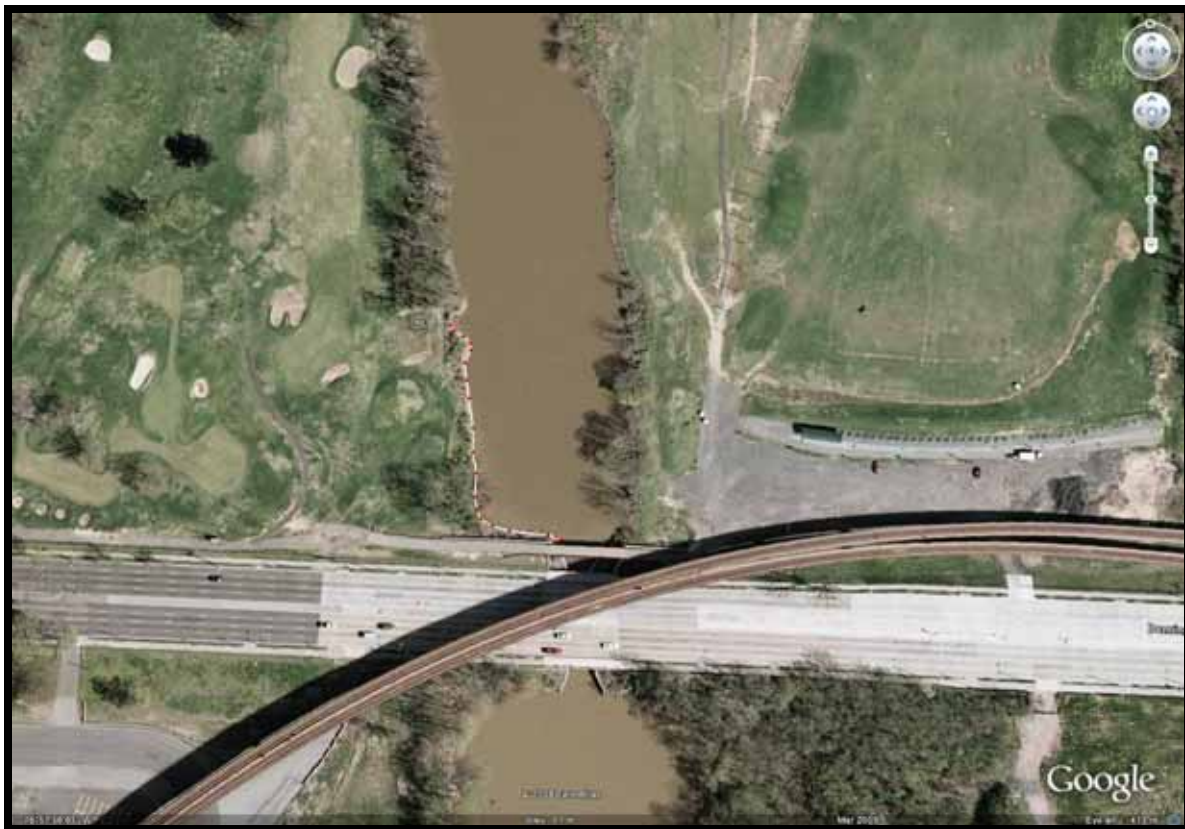
Figure 3.1.10
Kingman Lake Stations: Benning Road Bridge Upstream

CHANNEL VEGETATION, ROOTS, OBSTRUCTIONS: 2 - mostly mud banks

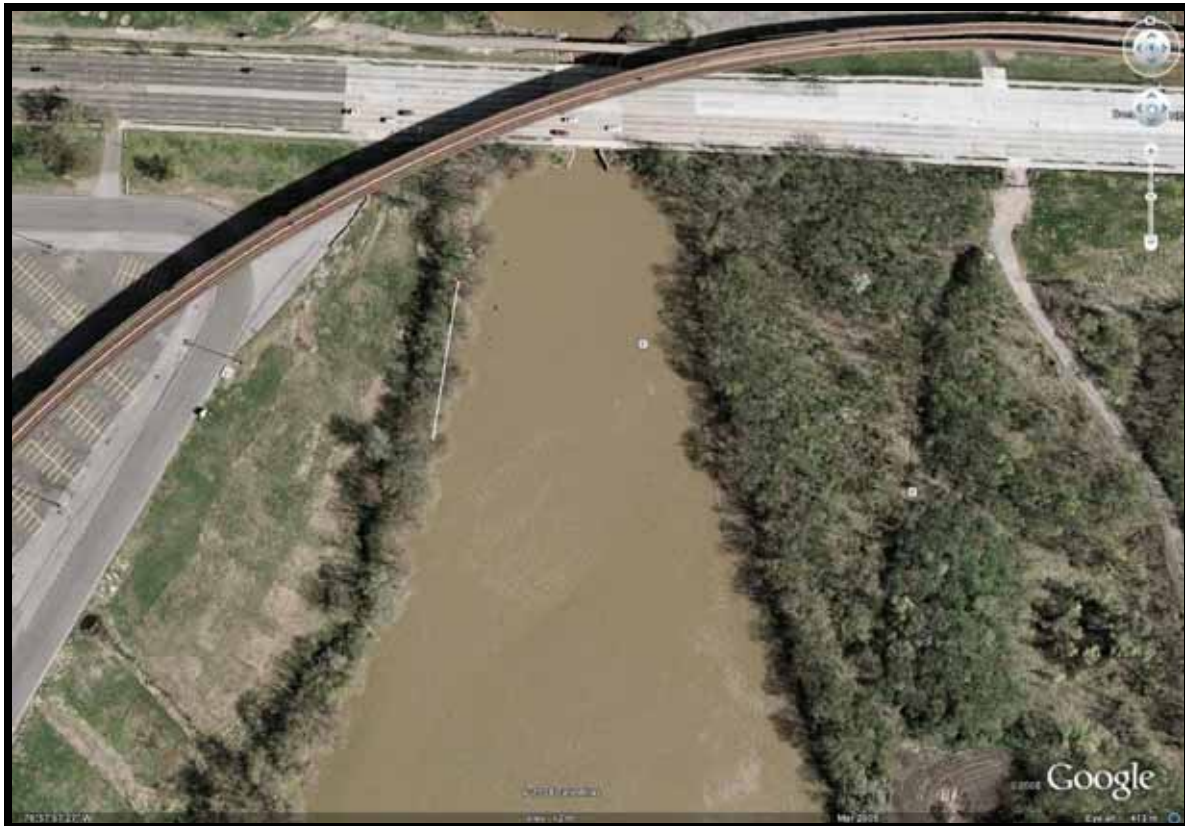
Figure 3.1.11
Kingman Lake: Benning Road Bridge Downstream

Transect located to avoid homeless person living under the Benning Road bridge.

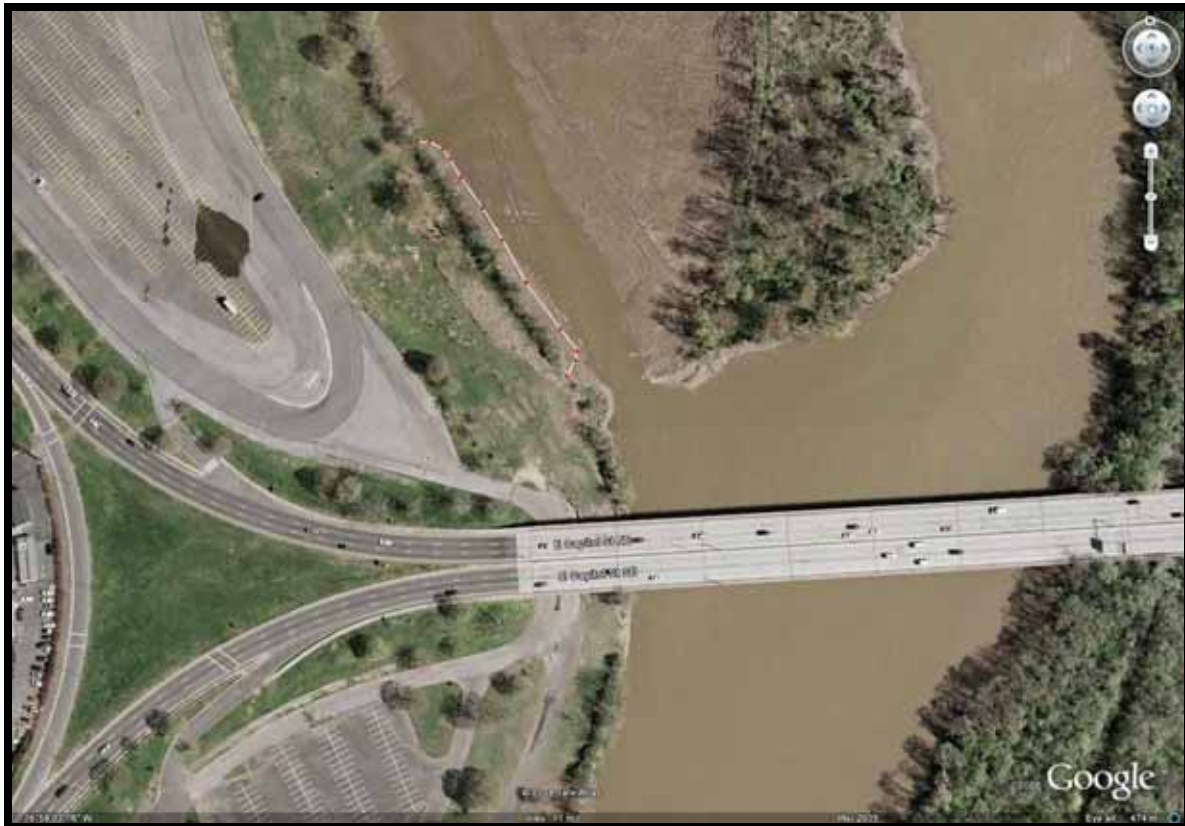
Figure 3.1.12
Kingman Lake: East Capitol Street Marsh

Survey conducted by walking along the marsh wall and counting trash on the water side of the retaining wall.

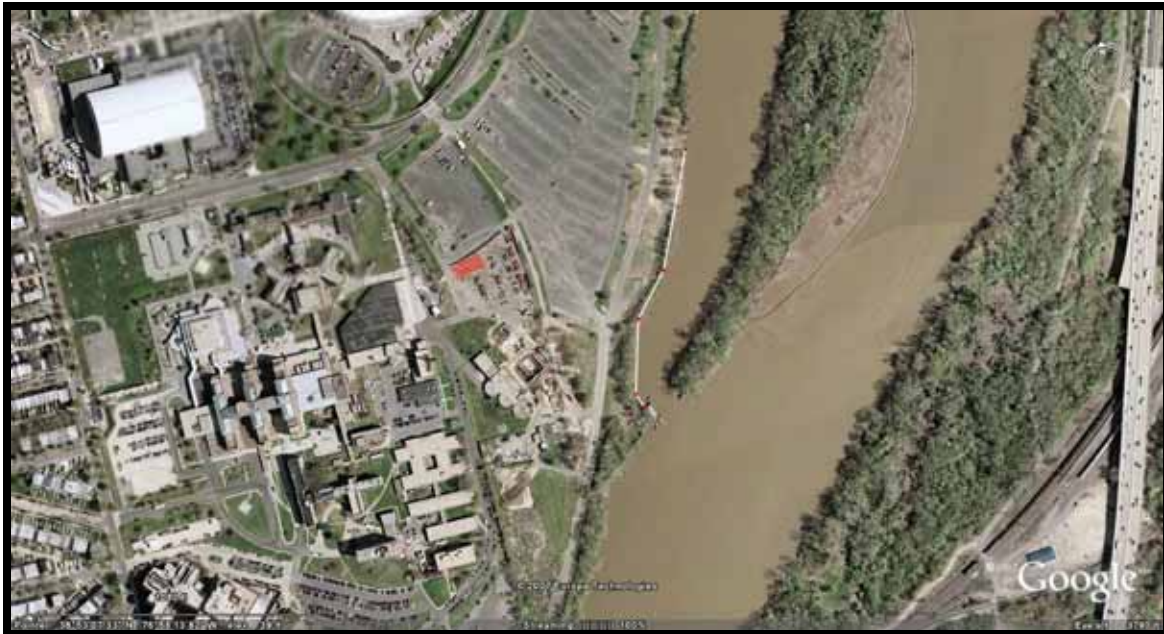
Figure 3.1.13
Kingman Lake: Northeast Boundary Sewer

This station is basically the intertidal zone.

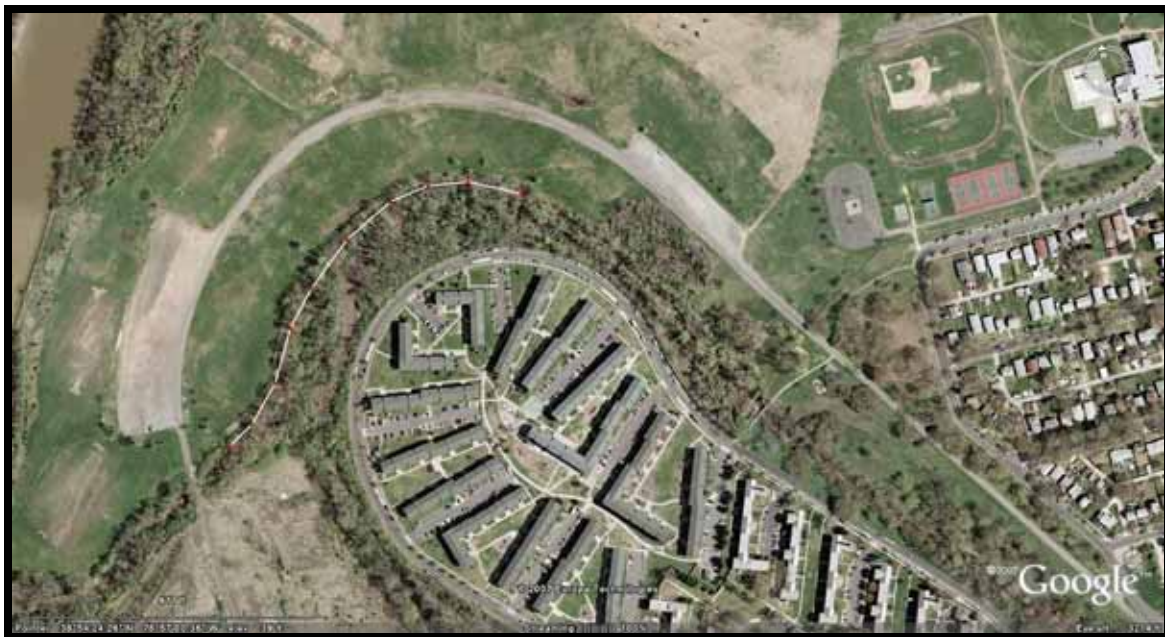
Figure 3.1.27
Watts Branch: Station 11 to small tributary.

Beaver dam at the Tributary and tidal affects

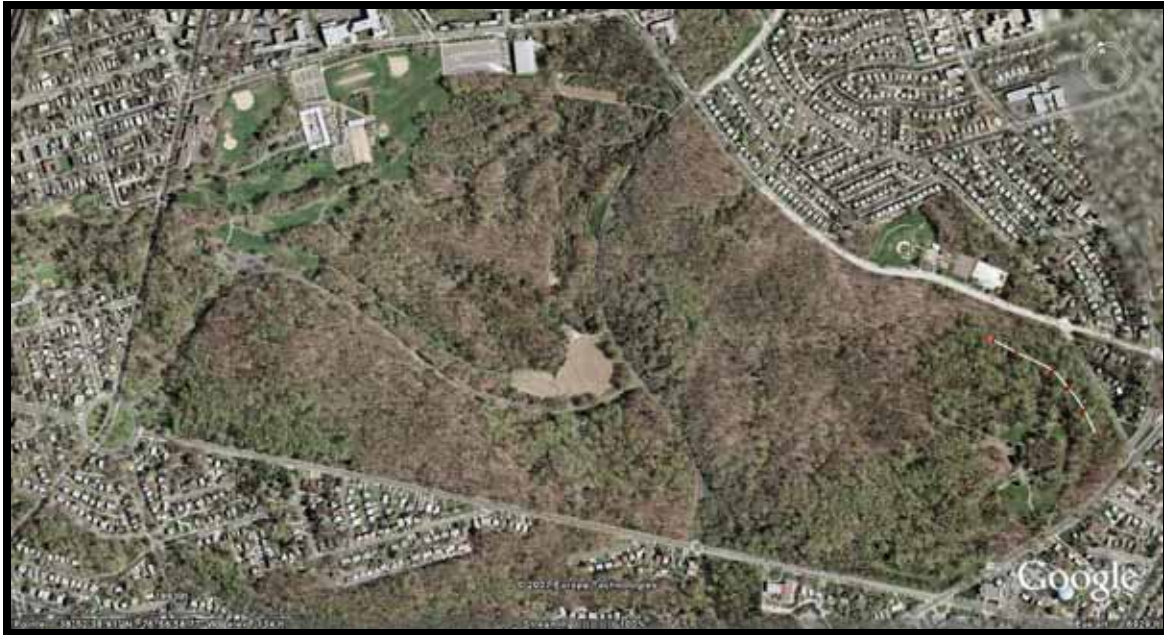
Figure 3.1.38
Ft. Dupont: Segment 1

This segment was dry and not monitored.

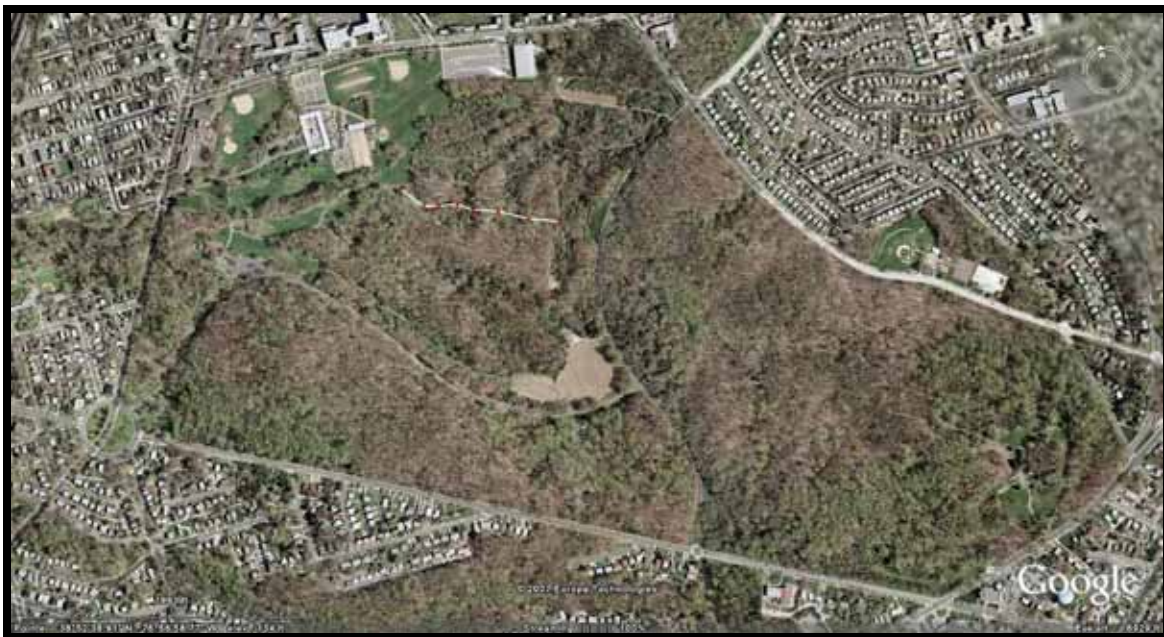
Figure 3.1.43
Fort Dupont: Ft Davis Dr – meadow

The beaver dam was broached by the NPS during the course of the study

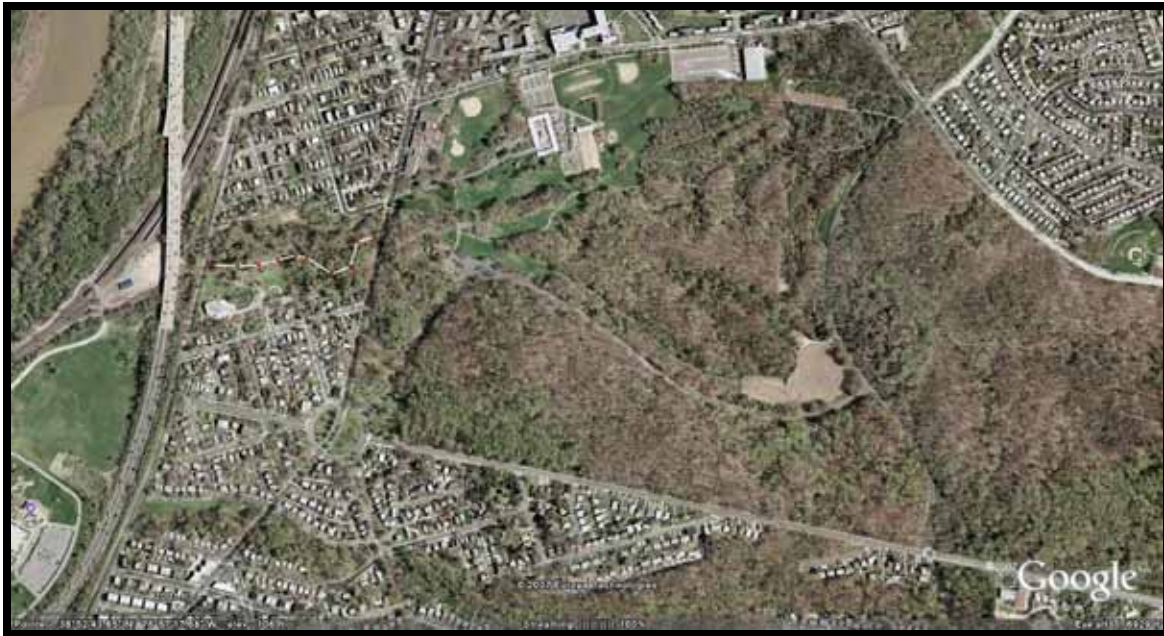
Figure 3.1.47
Fort Dupont: Minnesota Ave – Railroad

FDp-8. Minnesota Ave – Railroad
START DESCRIPTION: Minnesota Avenue
END DESCRIPTION: Pipe at Railroad
LENGTH: 1187'
WIDTH: 4'
BANKFULL DEPTH: 2'
CHANNEL VEGETATION, ROOTS, OBSTRUCTIONS: 2

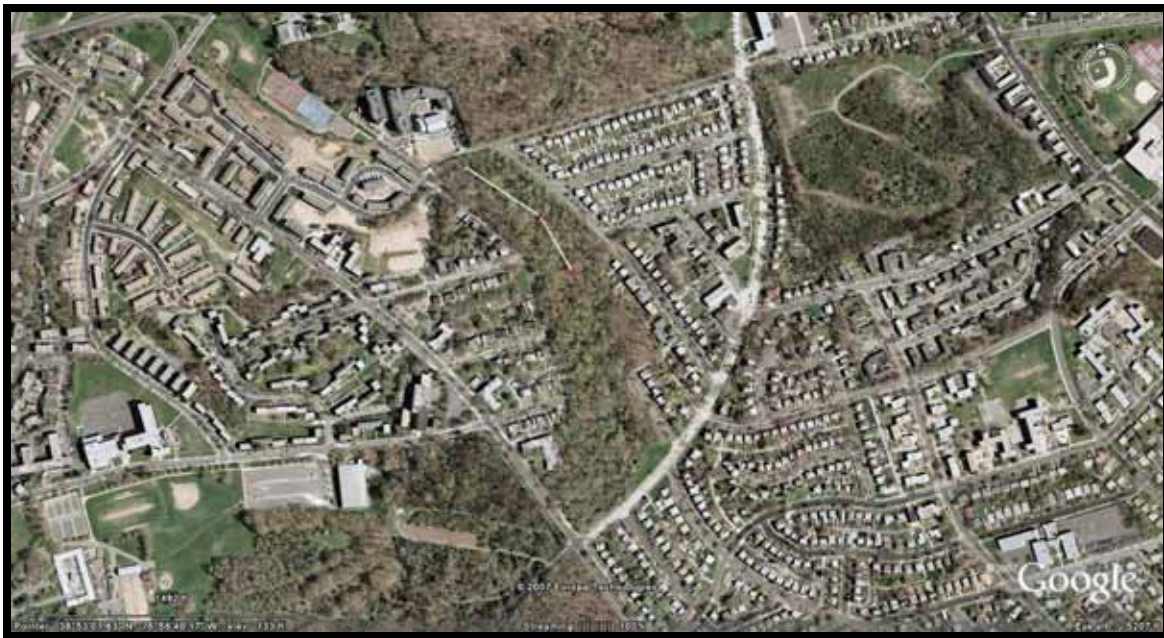
Figure 3.1.49
Ft. Chapin: Segment 1

START DESCRIPTION: Orange transect tape on fallen tree
END DESCRIPTION: TRASH RACK WITH 4 INCH SPACING
LENGTH: 750’
WIDTH: 15’
BANKFULL DEPTH: 3’
CHANNEL VEGETATION, ROOTS, OBSTRUCTIONS: 4

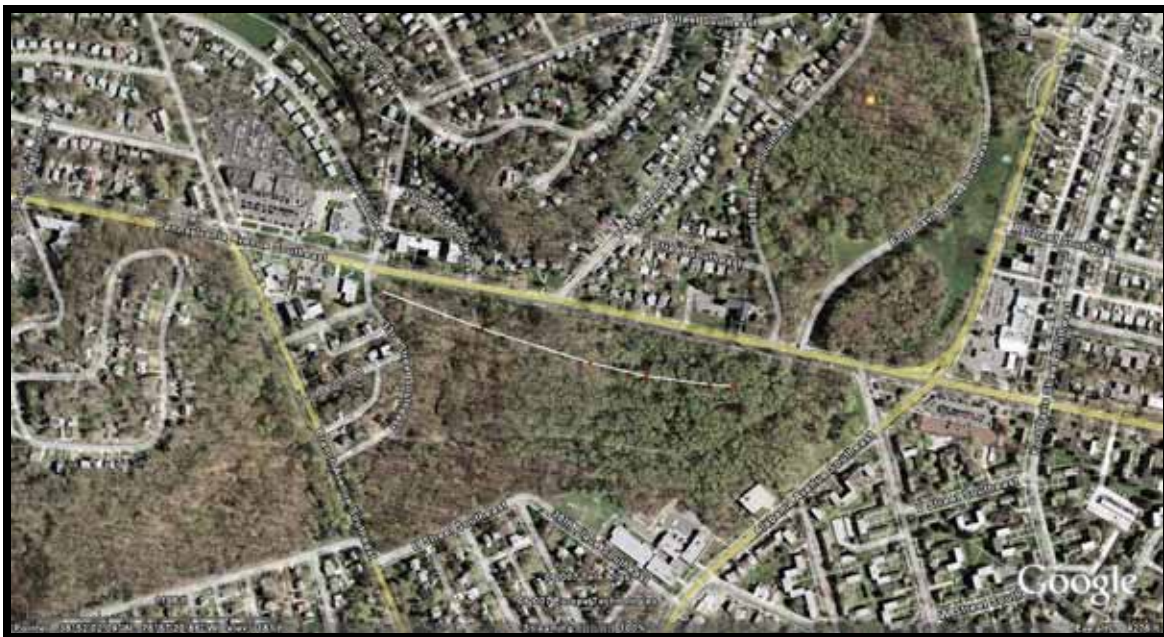
Figure 3.1.50
Fort Davis: 1

CHANNEL VEGETATION, ROOTS, OBSTRUCTIONS: 3

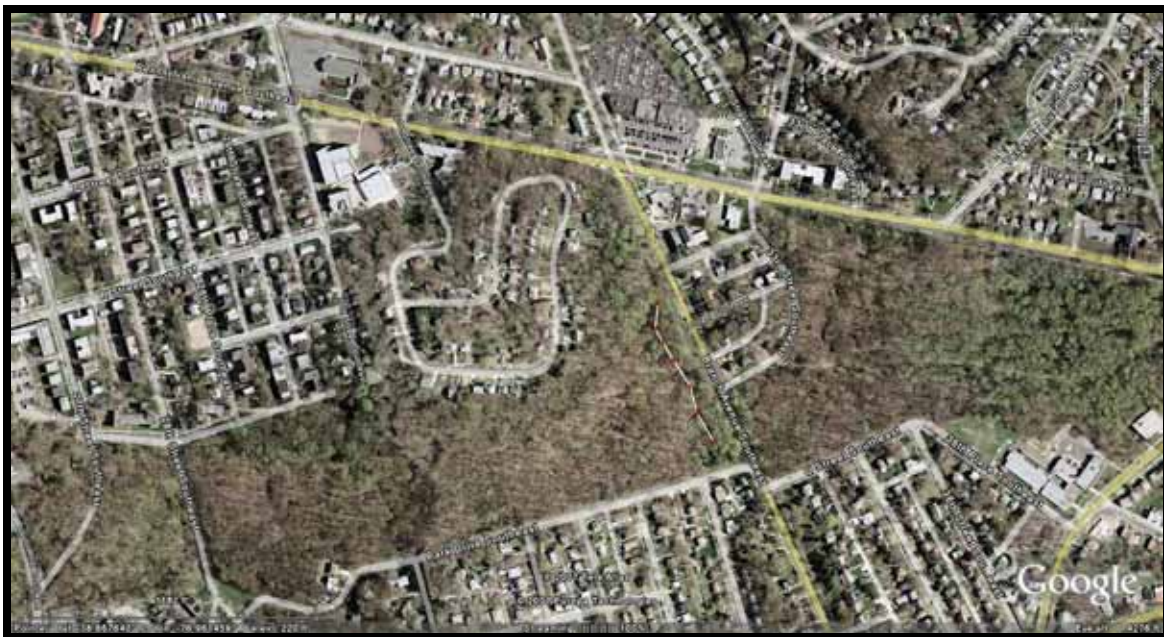
Figure 3.1.51
Fort Davis: 2

CHANNEL VEGETATION, ROOTS, OBSTRUCTIONS: 4

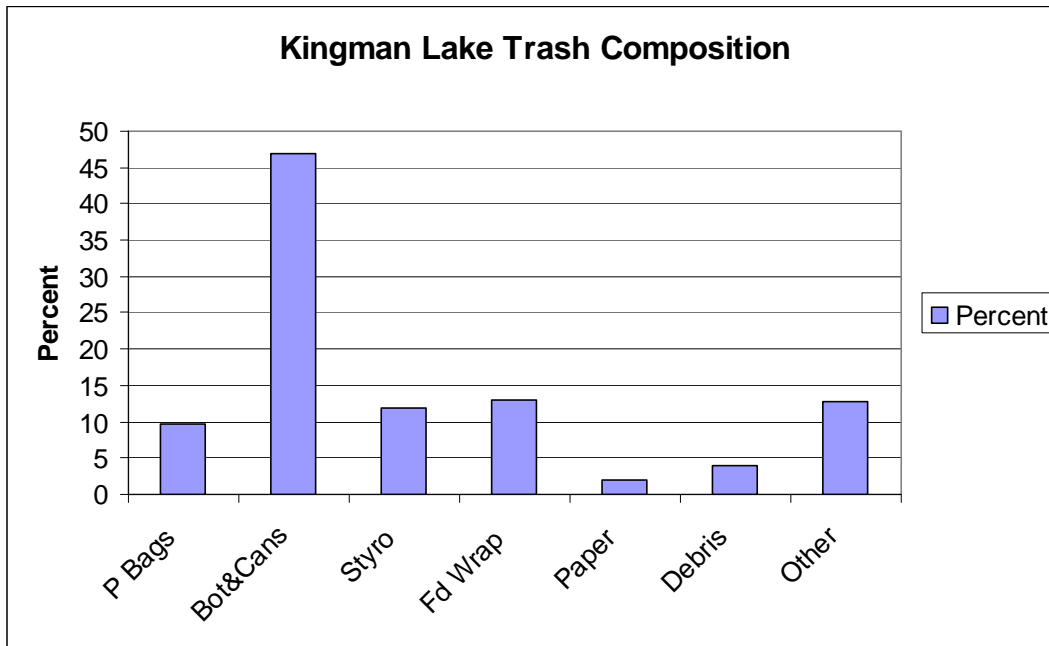
**Figure 3.2.6
Kingman Lake Trash Composition**

The composition of trash within Kingman Lake is characterized by a predominance of bottles and cans. These seem to come from the RFK parking lot as the underbrush next to the transect area is loaded with beer cans and beer bottles. It is unclear how high the counts would be without the underbrush to serve as a buffer zone, but perhaps three times more would be a reasonable estimate. What the data do not show is that a significant amount of debris is items such as grills and folding chairs from tailgating parties. About two percent of all items are composed of paper.

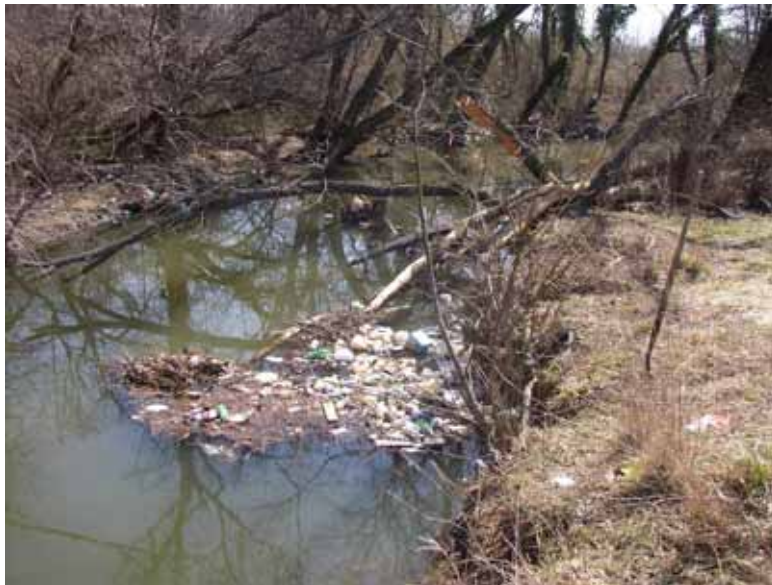
**Figure 3.2.20
Fall Survey**

Figures 3.2.20 & 3.2.21 below are two pictures of the same location, with one taken during the fall survey and one taken in the spring survey (see also the cover photo). There is an orange transect marking tape hanging from the tree limb in the far background. Trash is at least two feet deep but according to the survey methodology only the “visible” portion is counted.

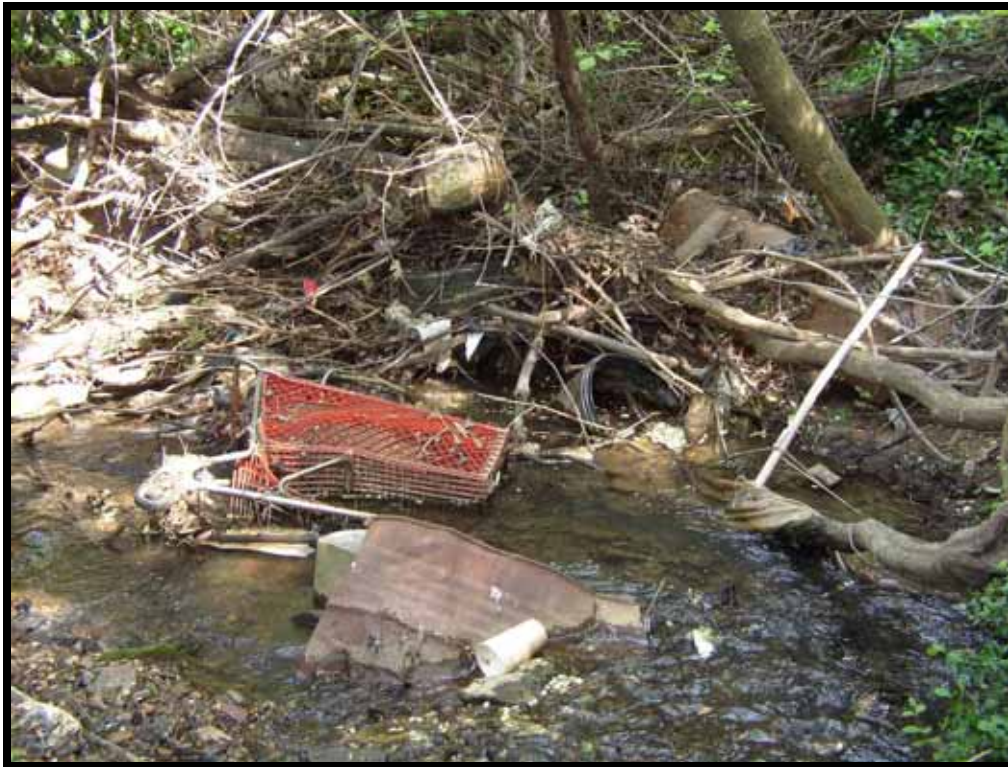
Figure 3.2.26
Debris in the Maryland segment of Watts Branch

Debris in the Maryland segment of Watts Branch is very high. This debris is dumped in two locations in Maryland and is transported downstream into the District. An interesting observation was that an amount of vinyl siding found in WB-1 in the summer was no longer in WB-1 in the fall, but had been scattered downstream. By the spring survey, it had reached the last three segments, and much of it was partially buried. There were two locations in the District where excessive dumping had actually caused items to reach the water, and action are recommended in the implementation plan for Watts Branch.

In the picture are the following items starting in the lower left and moving counterclockwise: length of pipe, 55 gallon drum, large picnic table umbrella, 55 gallon drum, hot water heater, plastic highway drum, tire, 5 gallon bucket, a car door, a wheel, and a shopping cart.
