CHAPTER 3

MONITORING DATA

3.1 Data Collection

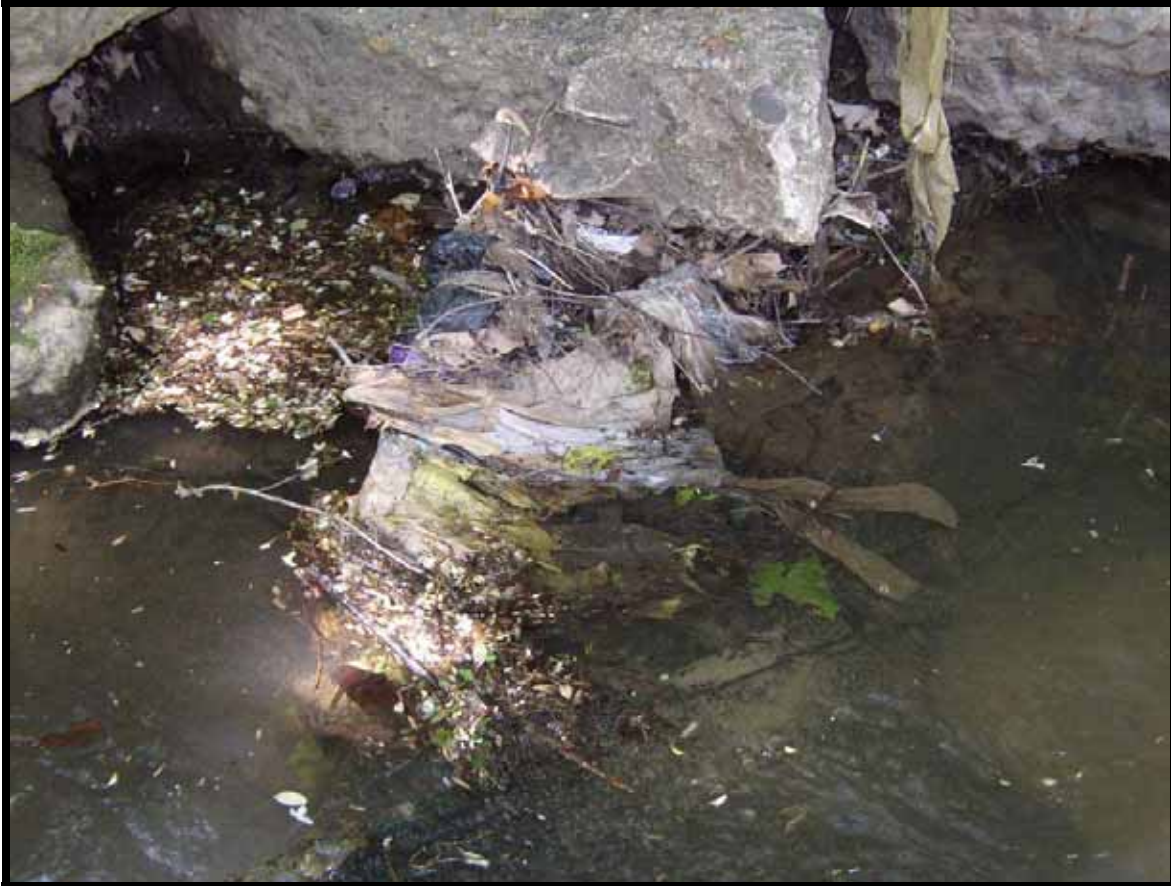
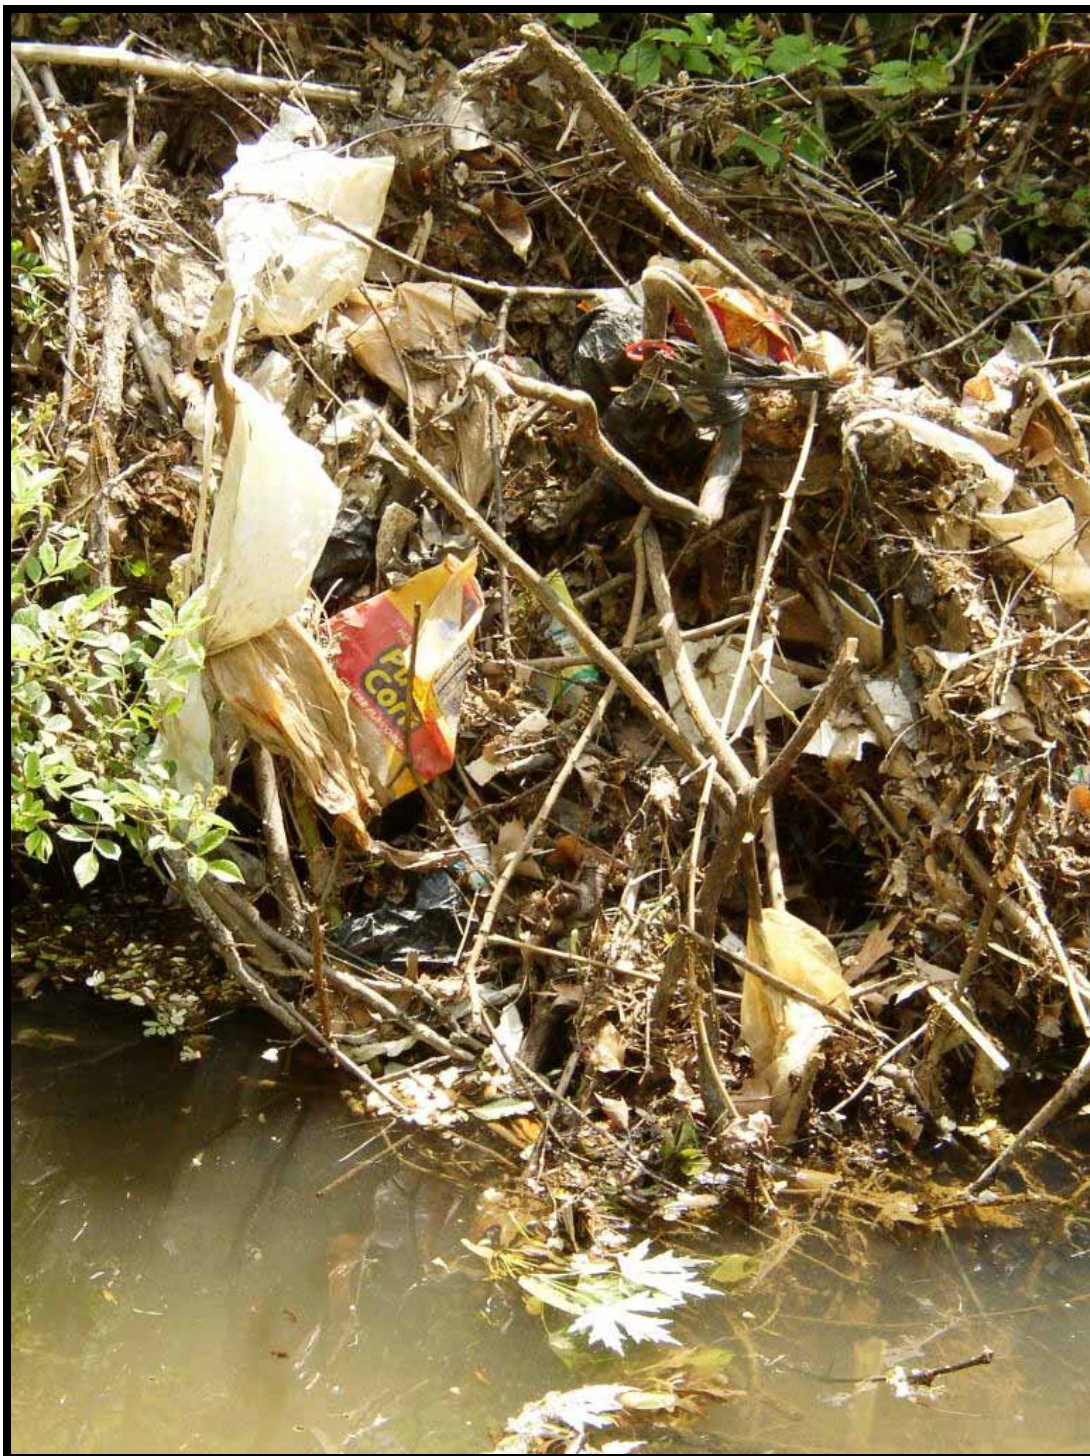
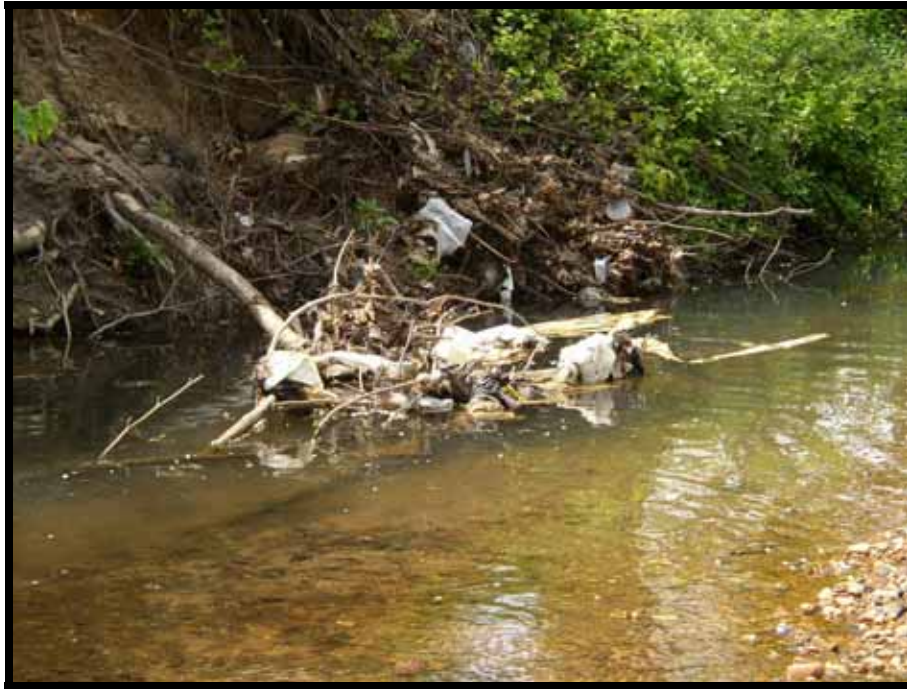
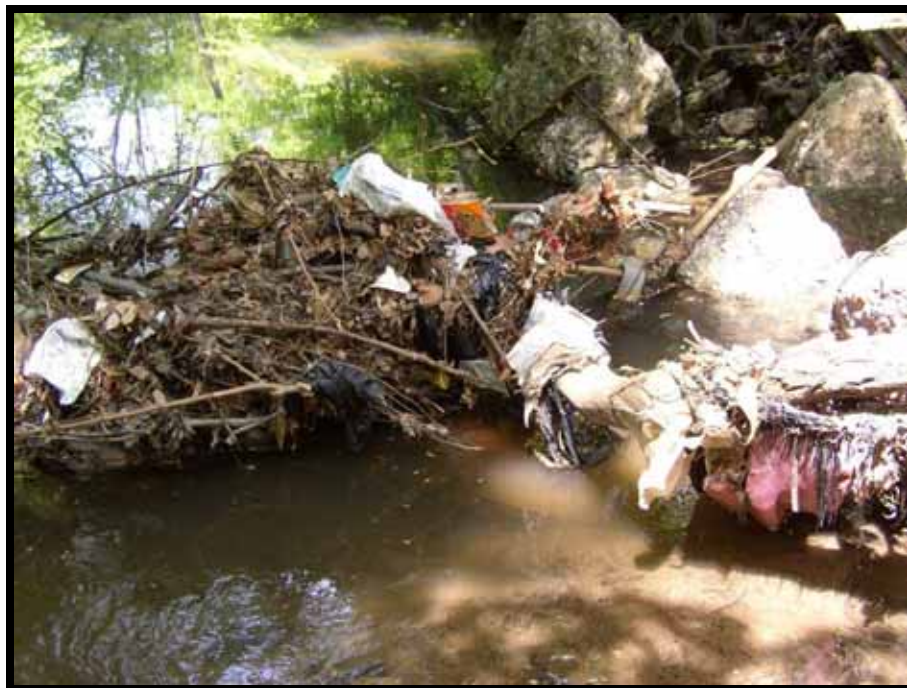
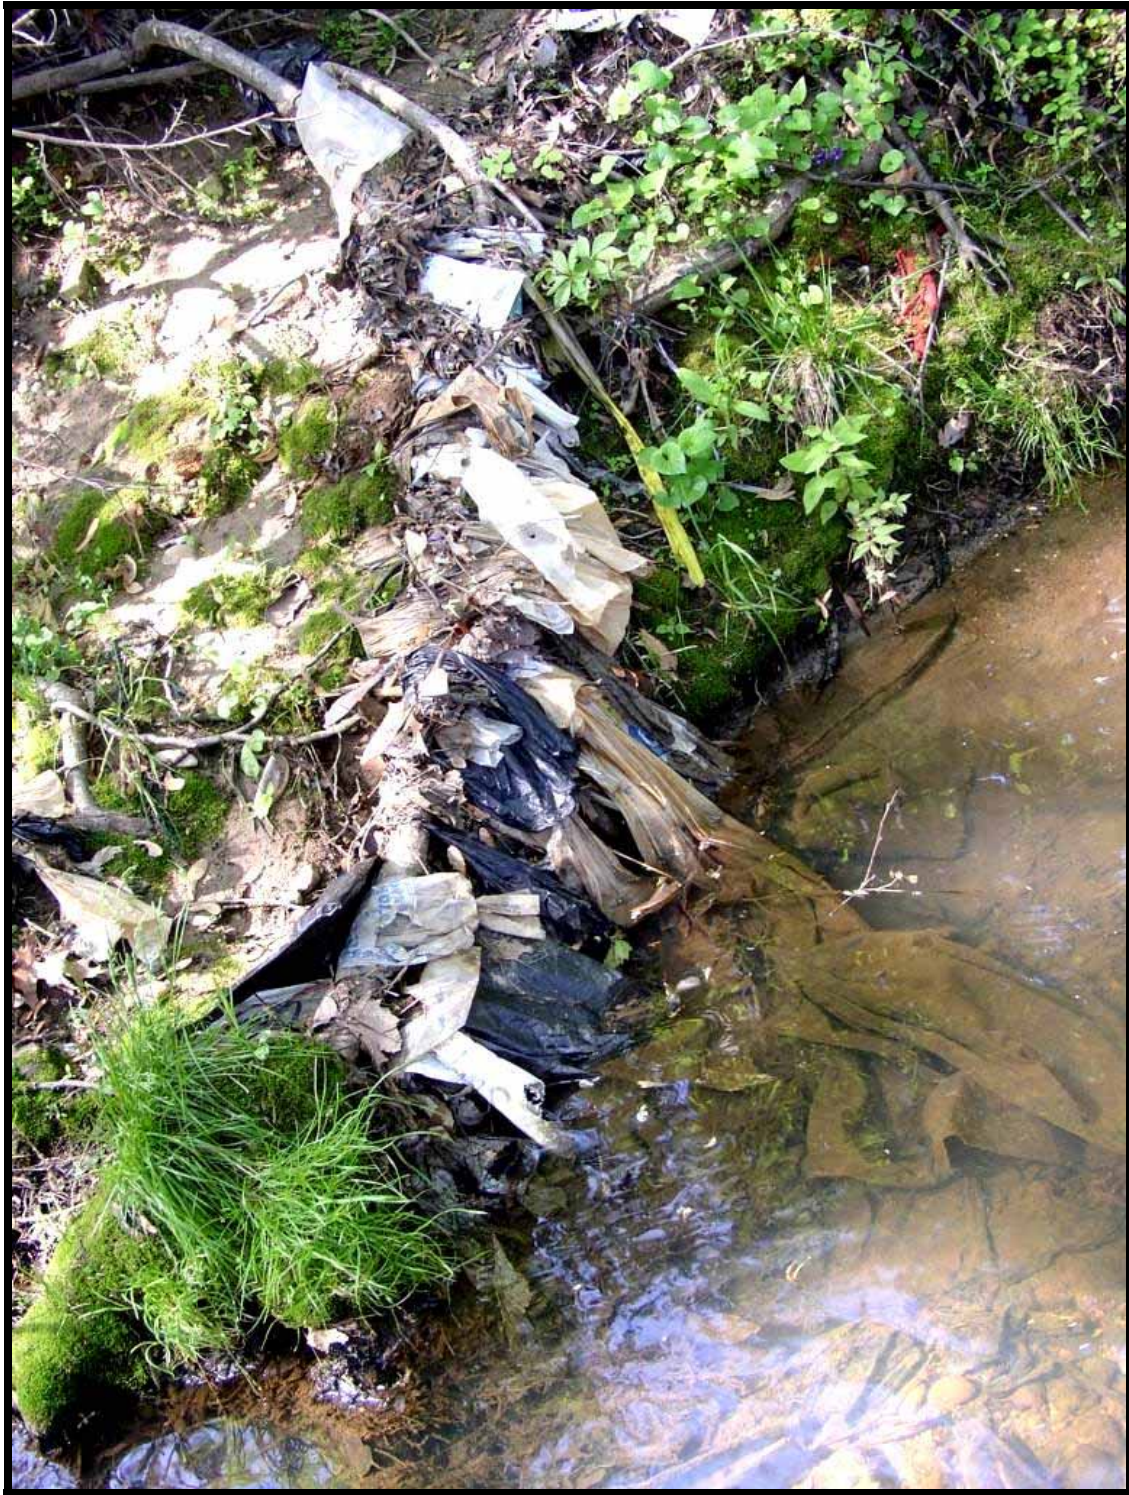
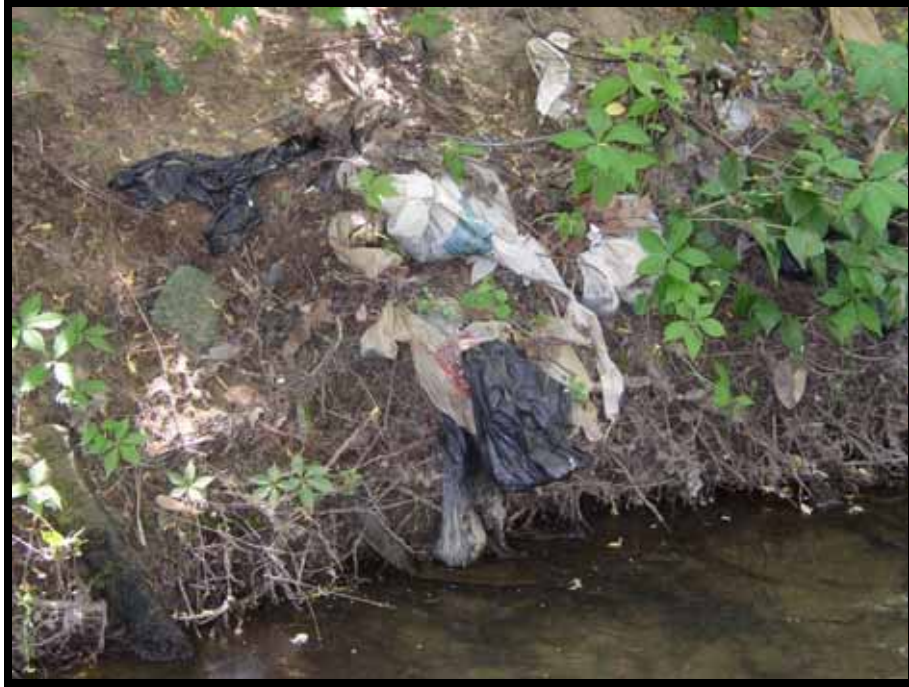
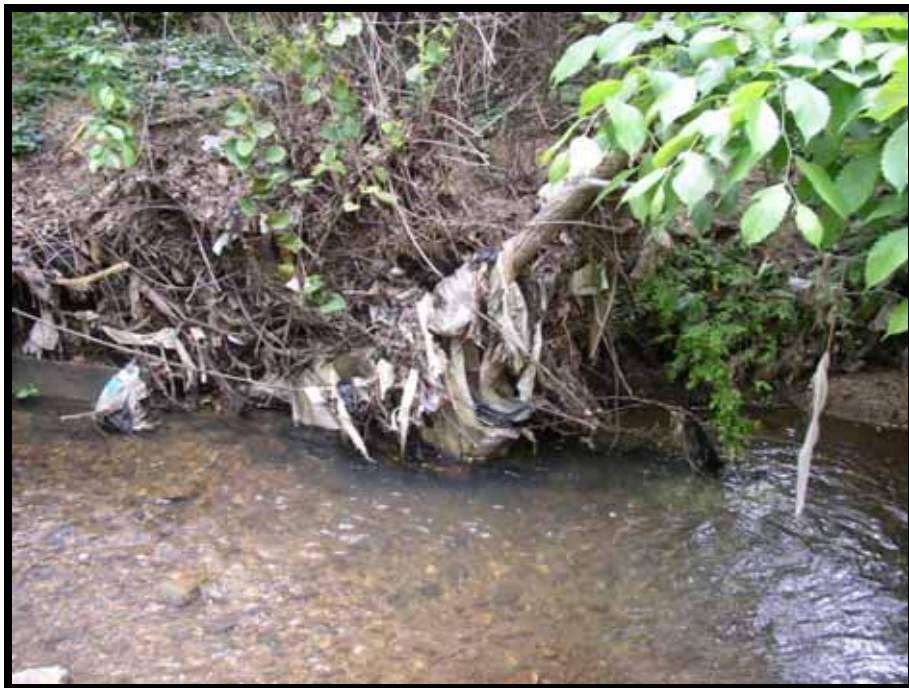
Watts Branch is the largest tributary to the Anacostia in DC and it is dominated by plastic bags. Over half of the trash is plastic bags as shown in Figure 3.2.27.

The only way to describe the blight is with pictures. The following photos (Figs. 3.2.28-3.2.34) provide an idea of what the stream looks like with that many plastic bags.

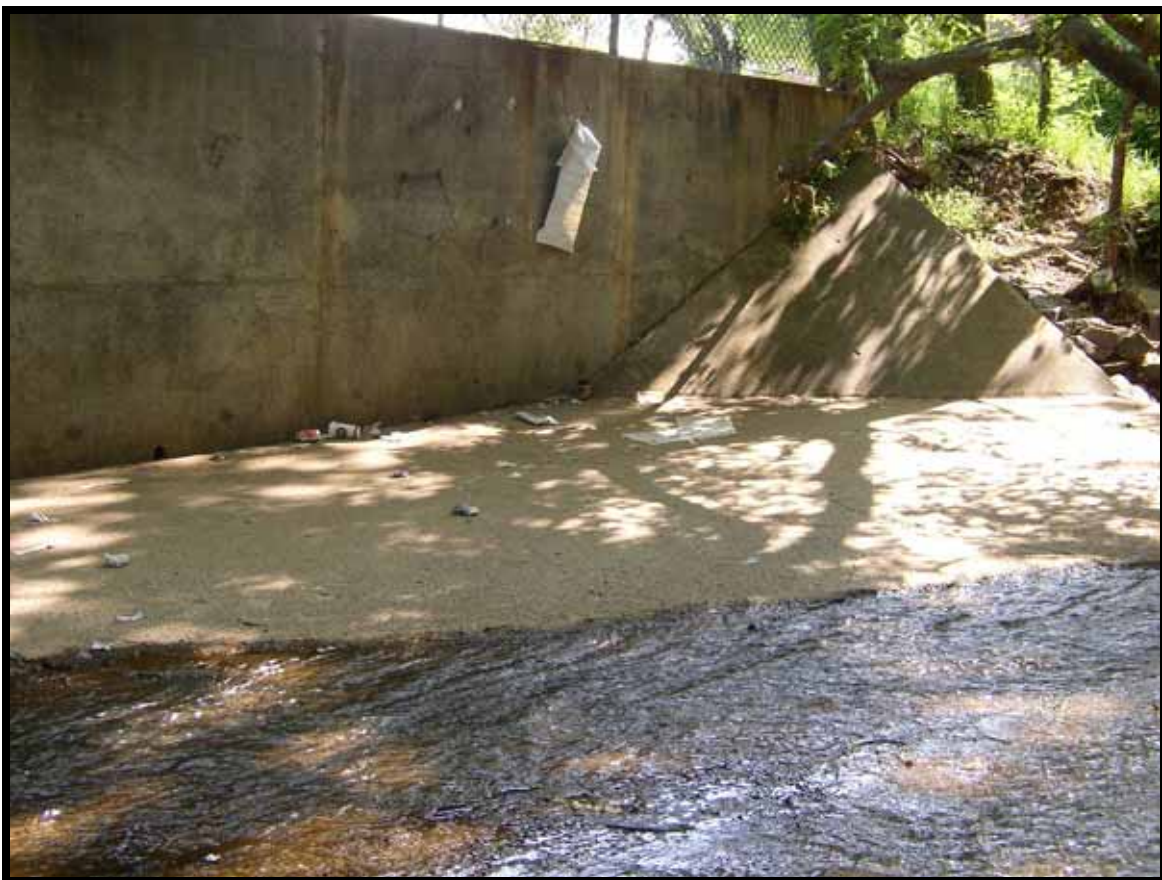
Figures 3.2.35 - 3.2.37 are pictures showing the effects drug users have on Watts Branch.

Figure 3.2.35
Paper bags and debris left where drug and alcohol users loiter

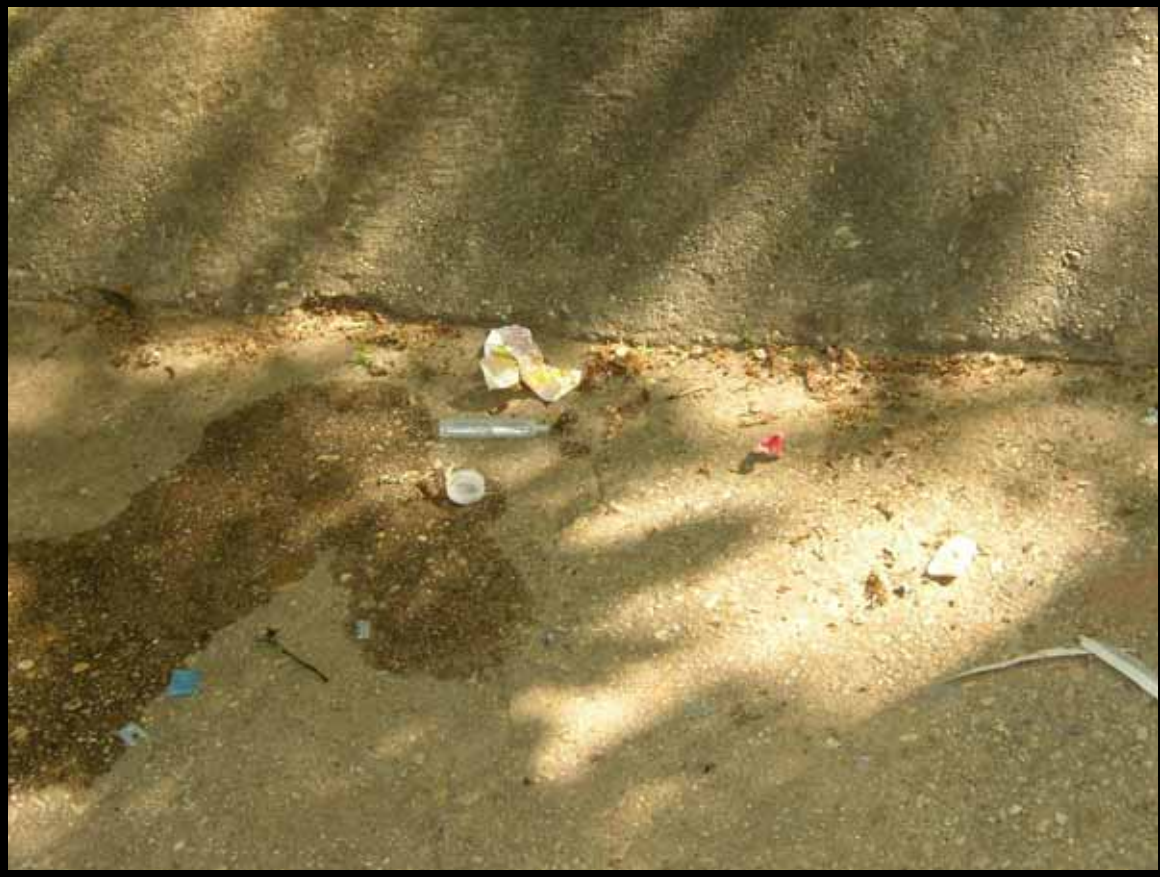
Figure 3.2.36
Drug paraphernalia found near streambed

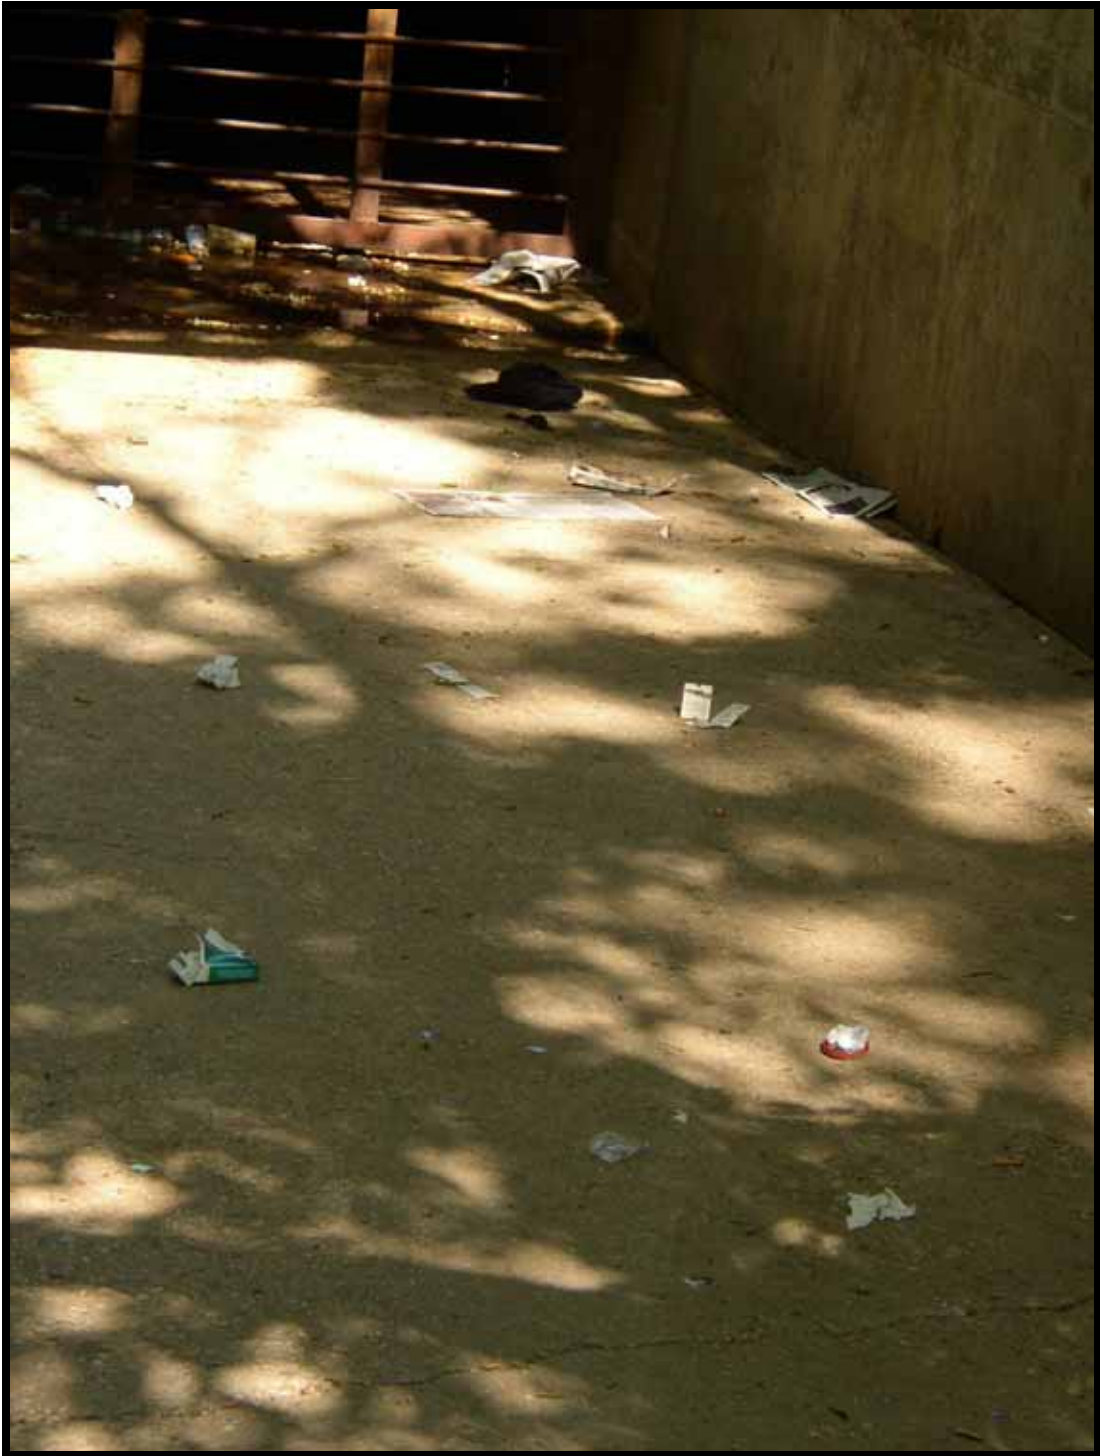
Figure 3.2.37
Trash found in the streambed

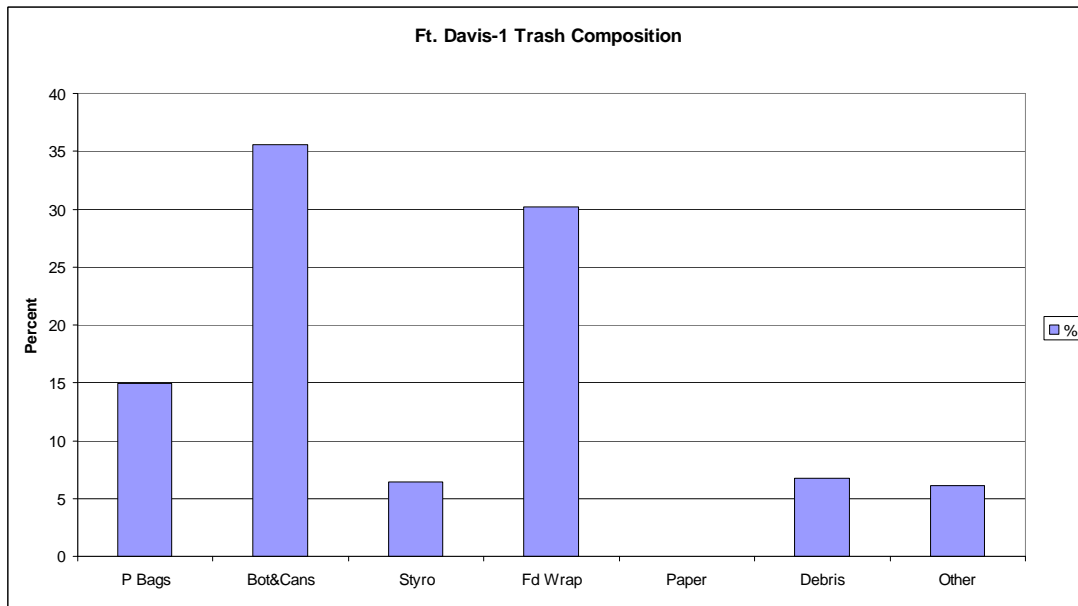
Figure 3.2.54
Fr. Davis – Trash Composition

In this stream bottles and cans predominate, possibly because there is little pedestrian activity, but mostly commuter traffic along Pennsylvania Avenue. There was absolutely no paper of any kind ever found in this stream (Figure 3.2.54).

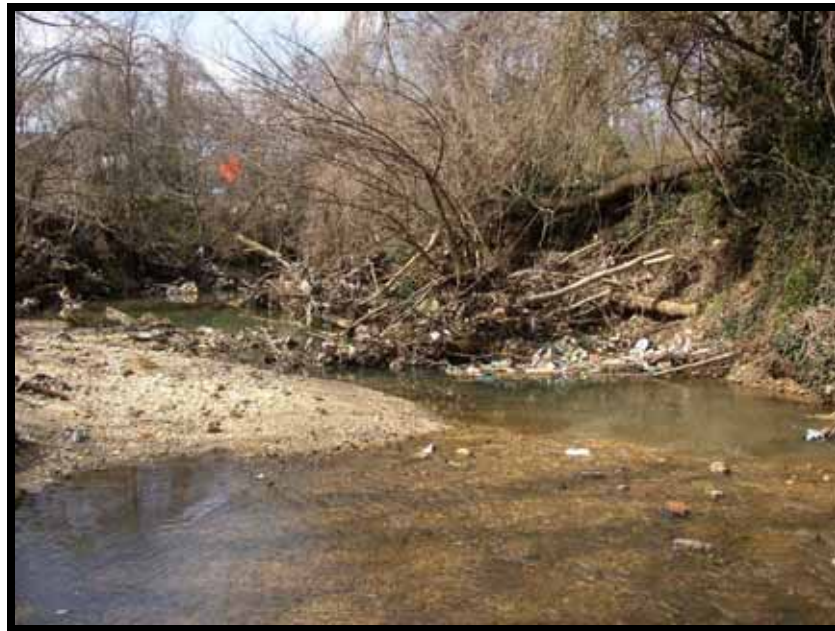
Logjams and natural trash straining blockages were also inventoried but did not provide a good index even though they do trap a lot of trash (Figure 3.2.67).

**Figure 3.2.67
Trash in logjam**

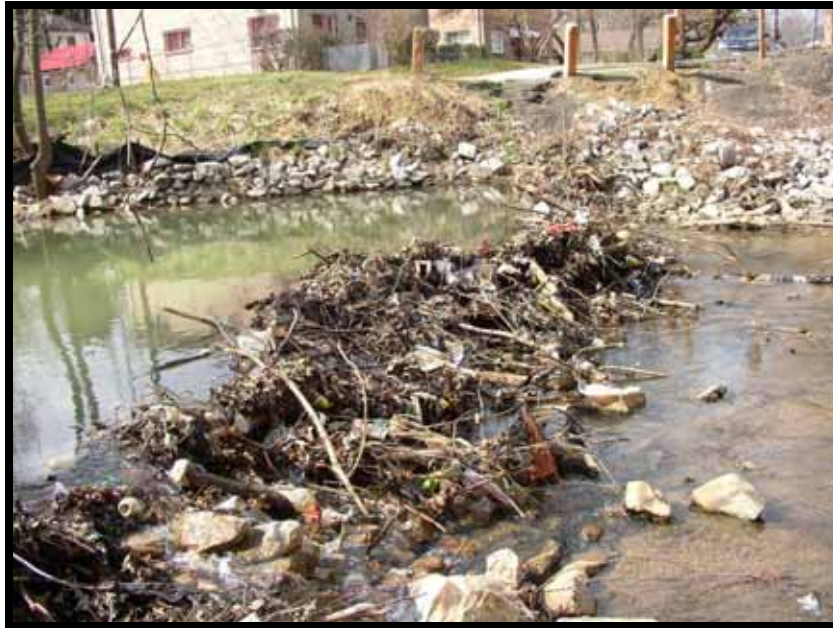
Even the beaver had to put up with trash when constructing his dam on Watts Branch.

Figure 3.2.68
Trash in Watts Branch beaver dam

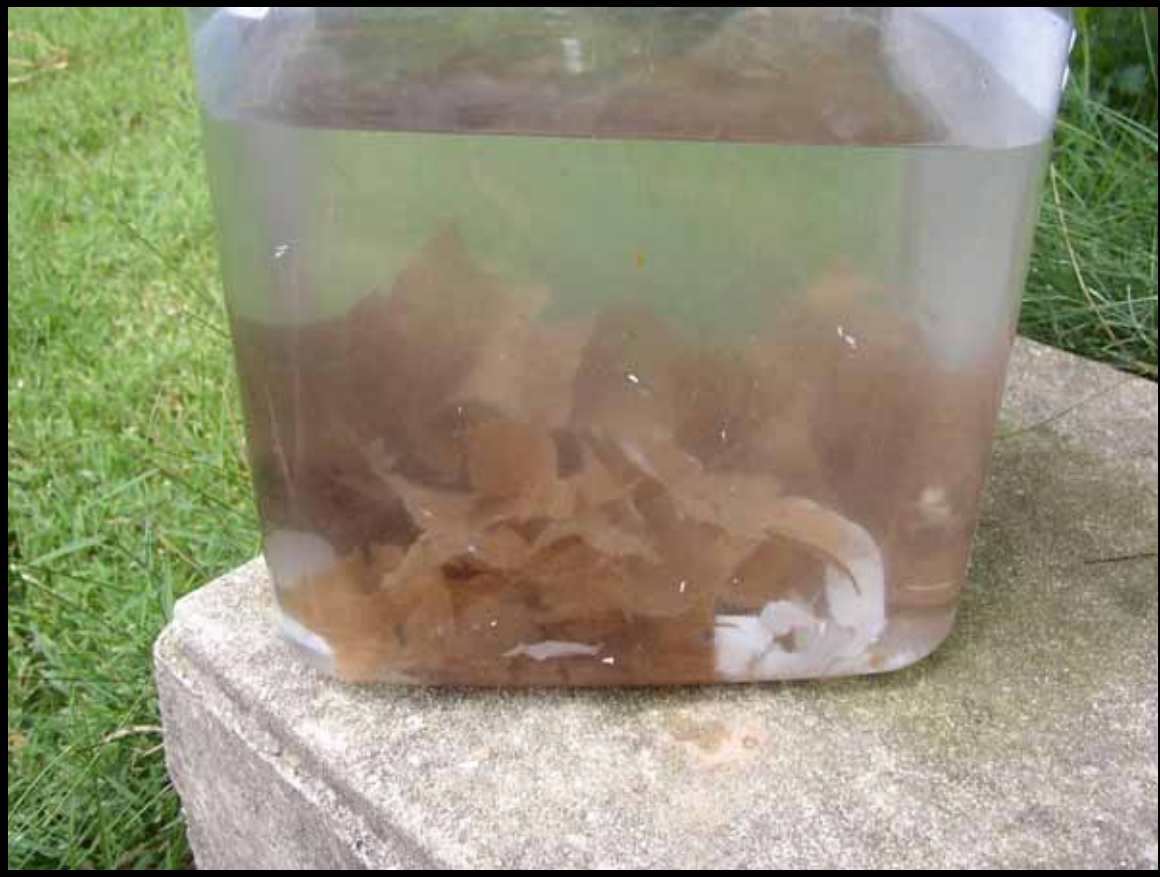
After one hour the jar was shaken for two minutes and observed. The bag and receipt were reduced to pieces of about two inches square or less as shown in Figure 3.2.69.

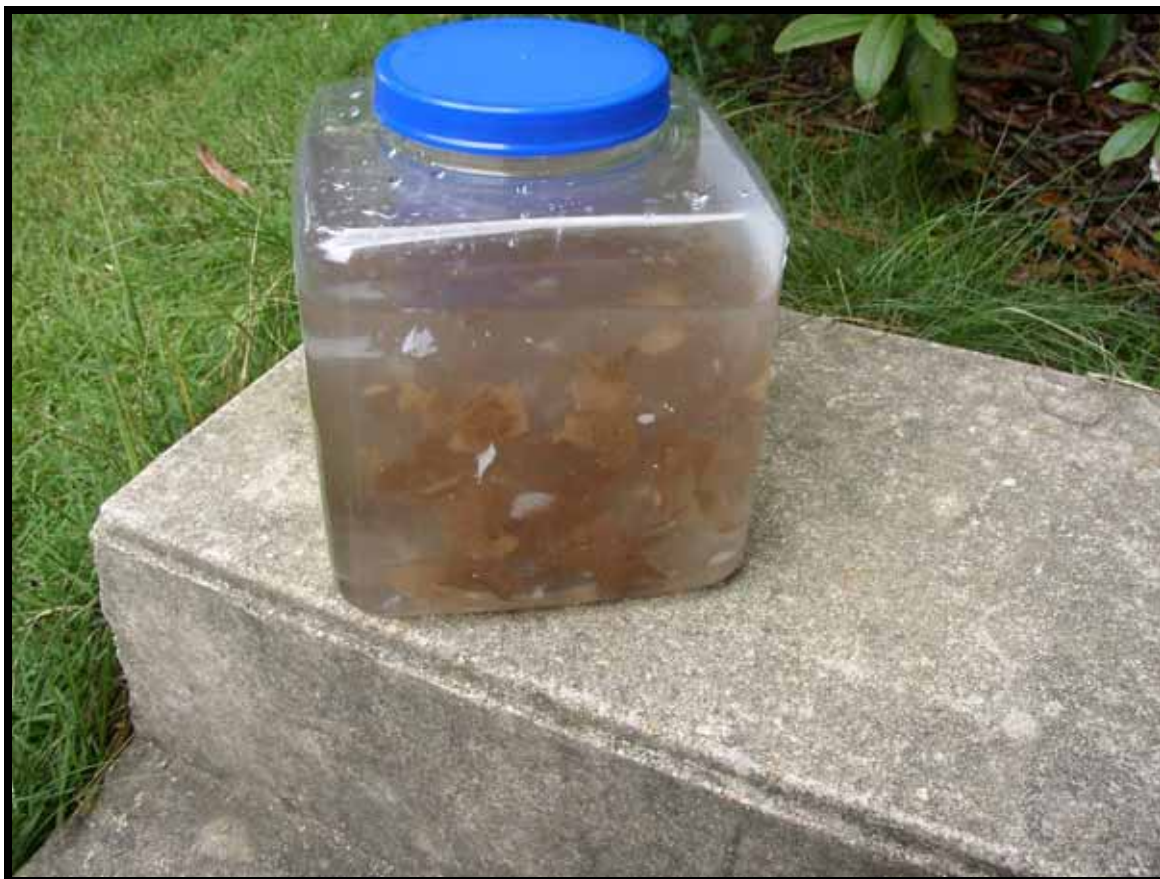
The jar was allowed a quiescent period of one more hour and shaken for two minutes again. The paper separated into even smaller pieces as shown in Figure 3.2.70.

It is concluded that a paper bag lying in the gutter of a road will not survive the rainfall and being transported down the concrete curb and gutter and falling into the catch basin. It will be macerated with other trash, sticks and sand. Then, from the catch basin, it travels down the concrete sewer to where empties into the stream. A plastic bag was subjected to the jar test and showed no changes. It is concluded that only the plastic bags will survive such a high energy transport along the curb, into the catch basin, and down the sewer into the stream.

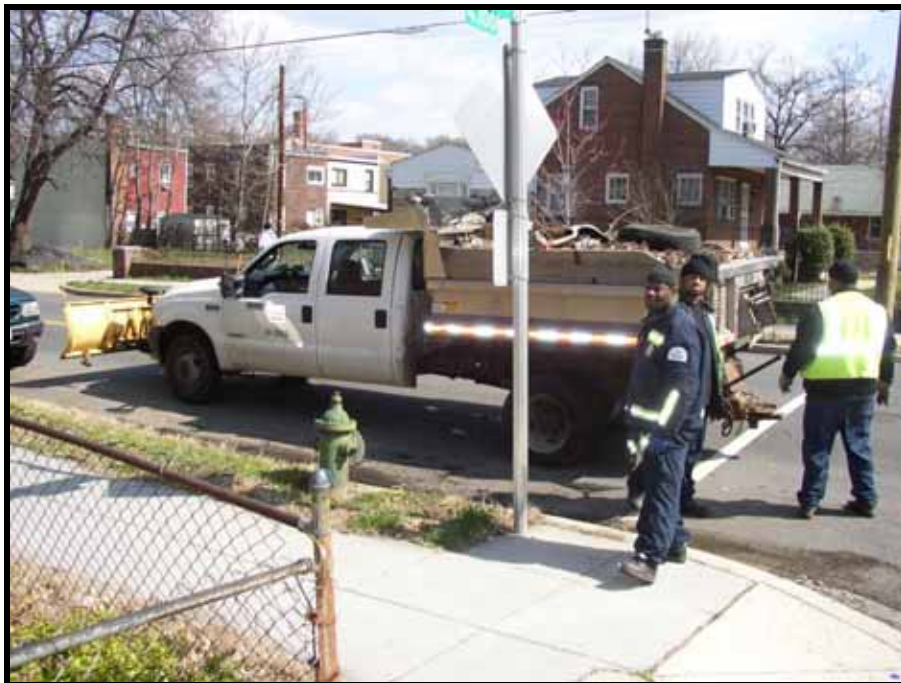
Figure 3.4.7
DPW crew removing leaves and trash from curb in Watts Branch sub-watershed

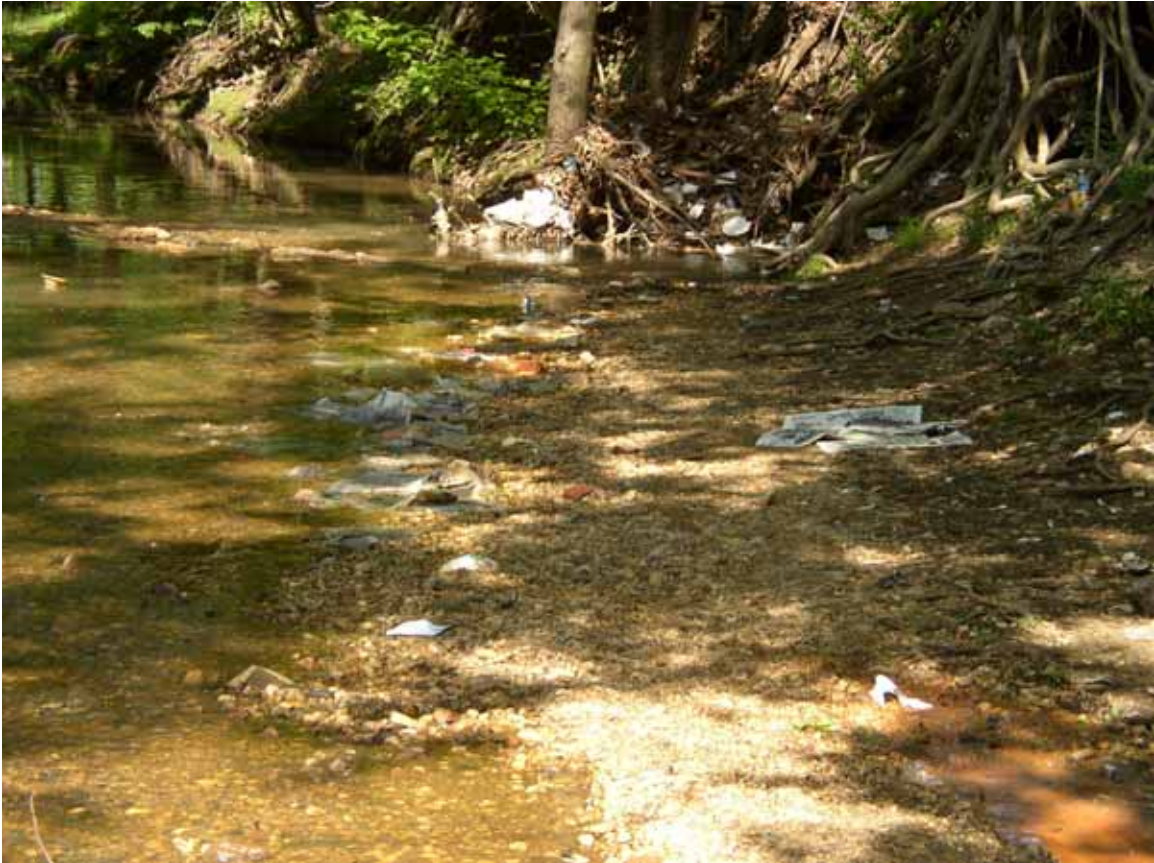
Below is an example of some paper that was counted in Watts Branch (Figure 3.5.4). It originated from the homeless drug users that frequent the area (one can also see a plastic bottle and cup sat upright by the individual and a Styrofoam plate). The other source of paper was the paper bags from beer singles. They were found usually within throwing distance of a bridge. Paper clamshells food containers were a rarity in the streams.

Figure 3.5.4
Example of some paper that was counted in Watts Branch

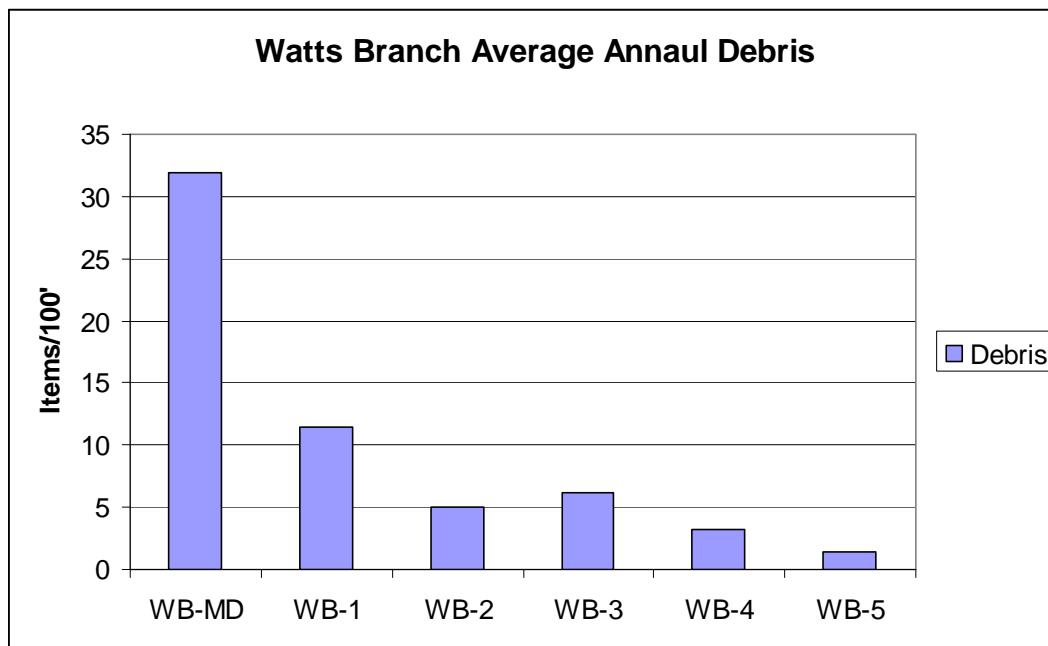
The Maryland station on Watts Branch (WB-MD) had very high levels of trash compared to the nearby downstream stations in DC (Figure 3.5.14). The amount of debris in the Maryland segment was over 30 items per 100 feet of stream channel.

Figure 3.5.14
Watts Branch – Average Annual Debris
